Inspection Report

Property Address:
307 Hidden Drive
Winchester TN 37398

Belmar Home Inspections

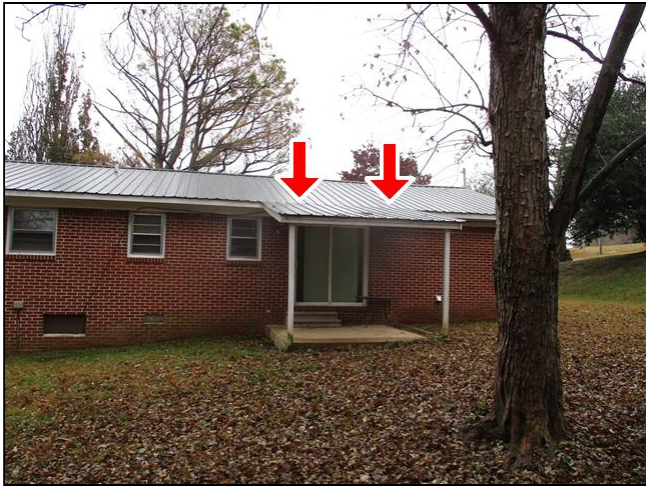
1.1 Item 4(Picture)

(3) It appeared that transition flashing was not installed where the roof pitch changes at the back of the home. Transition flashing helps prevent water intrusion. We recommend that a qualified roofing contractor evaluate and make any needed repairs or replacements.

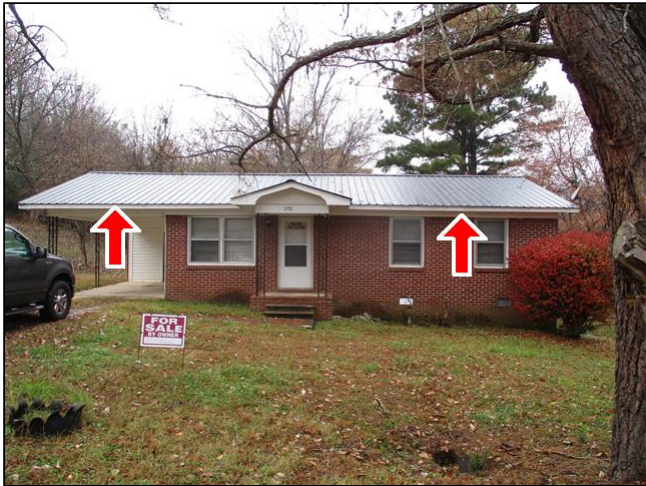
1.2 Item 1(Picture)

It appeared that gutters and downspouts were not present on the home. We recommend to install gutters and downspouts to help divert water away from the foundation.

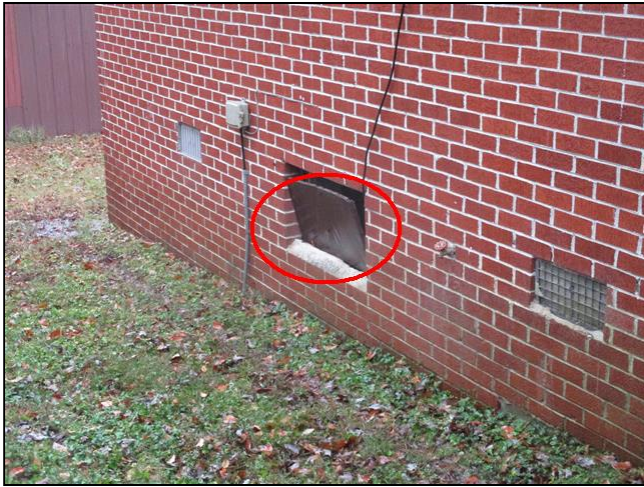
2.1 Item 3(Picture)

(2) The crawl space door would not latch/stay in place. Repair or replace as needed.

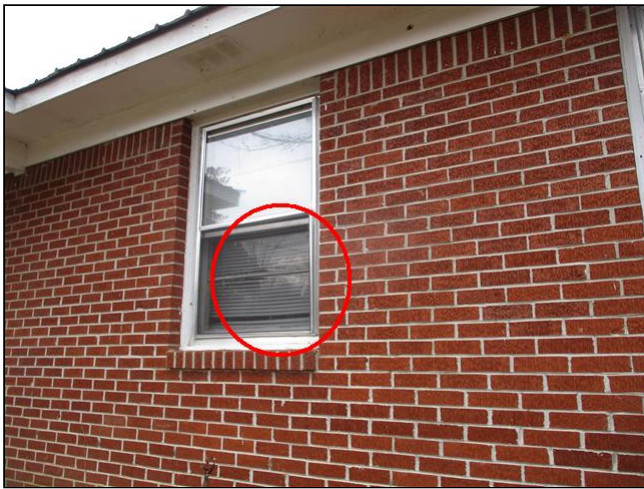
2.2 Item 1(Picture)

(1) It appeared that one screen was not secured well on one window at the front of the home. Also, it appeared that two or more of the window screens were missing. Repair or replace as needed.

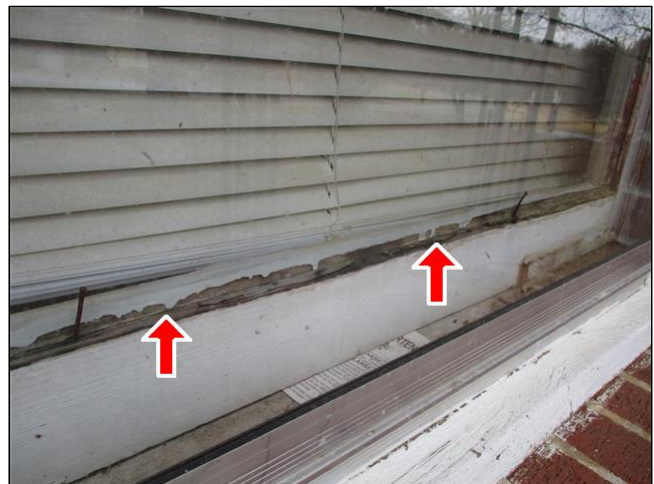
2.2 Item 3(Picture)

(2) The exterior window glazing compound appeared to be deteriorated/loose/missing on some windows. Repair or replace as needed.

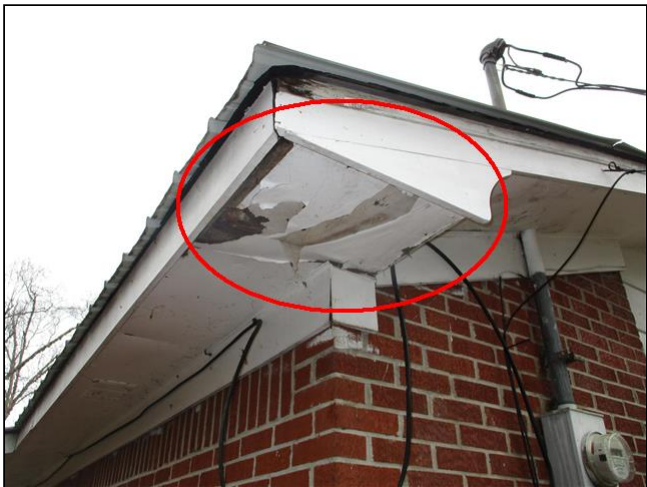
2.5 Item 1(Picture)

We noted what appeared to be deterioration/water damage along the eaves in a few areas around the home. Repair or replace as needed.

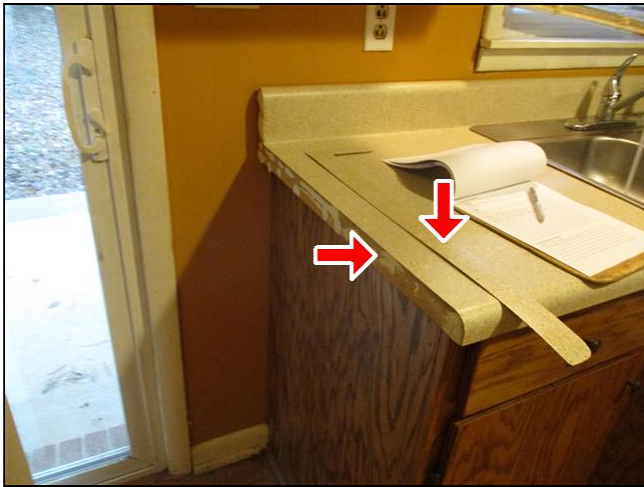
3.3 Item 1(Picture)

The laminate end caps for the countertops appeared to be detached at the kitchen. Repair or replace as needed.

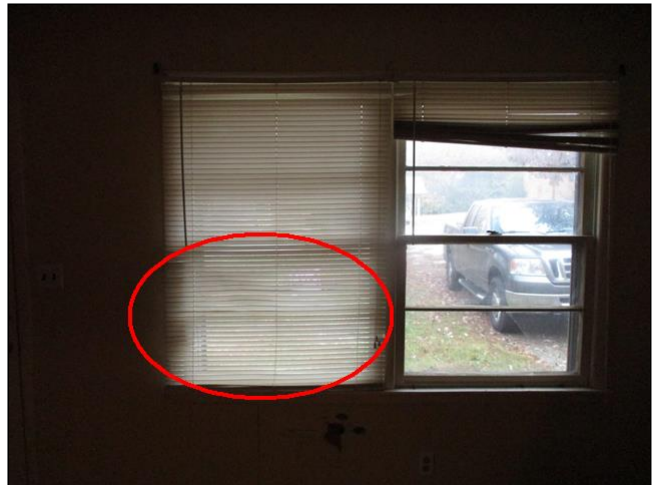
3.5 Item 2(Picture)

(1) We were unable to get the window to open at the kitchen and one at the living room. Repair or replace as needed.

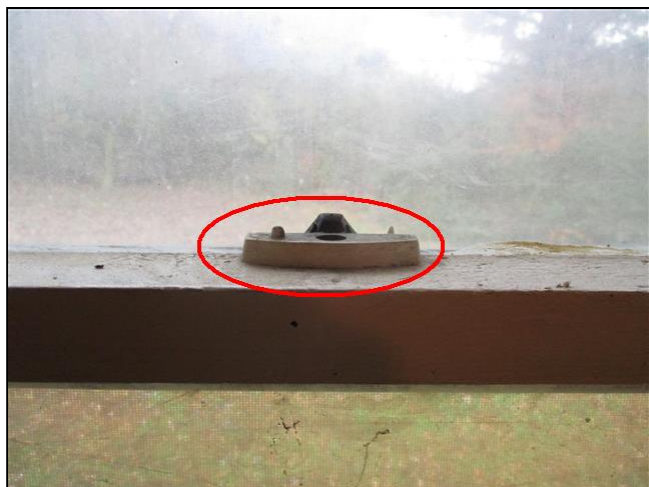
3.5 Item 3(Picture)

(2) The latch appeared to be missing/damaged on one window at the back corner bedroom. Repair or replace as needed.

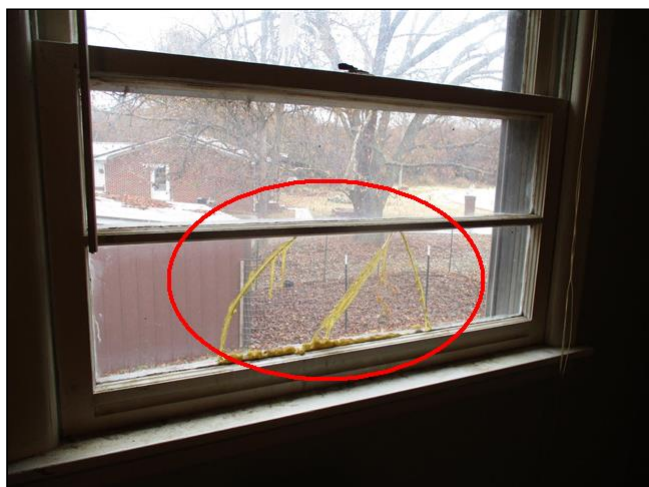
3.5 Item 4(Picture)

(3) The glass pane appeared to be damaged on one window at the back corner bedroom, the window at the front middle bedroom and one window at the living room. Repair or replace as needed.

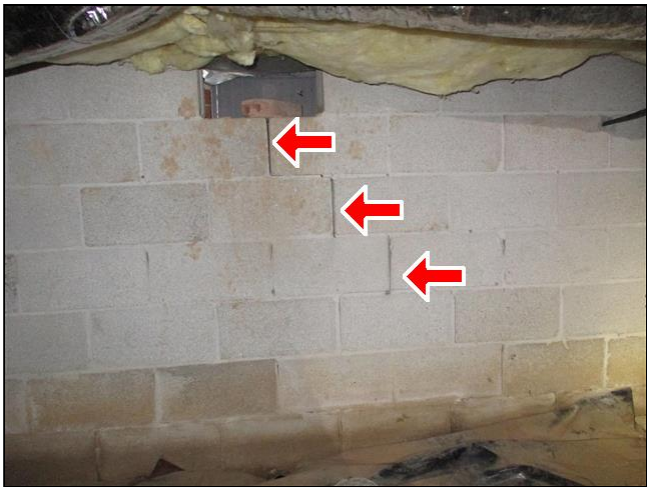
4.0 Item 5(Picture)

(1) The exterior brick wall cladding revealed cracks indicating movement near one window at the gable on the right side of the home. Also, the masonry block foundation wall revealed cracks along the mortar joints indicating movement on this same end of the home at the crawl space. We recommend that a qualified contractor evaluate and make any needed repairs or replacements.

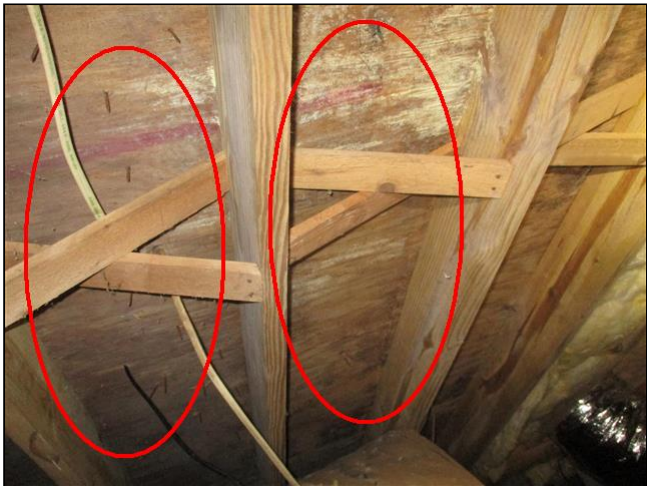
4.0 Item 6(Picture)

(2) We noted what appeared to be potential fungal growth present on the floor assembly in various areas at the crawl space. We recommend further evaluation by a qualified mold remediation contractor.

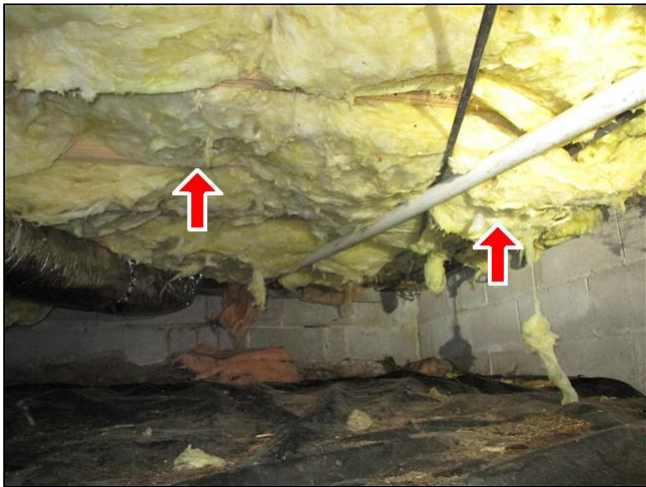
4.0 Item 12(Picture)

(3) Insulation was present between the floor joists at the crawl space. When the outside temperature is hot/humid and the HVAC system is operating in cooling mode(the duct work sweats in most crawl spaces), the moisture content tends to be higher at the crawl space. When the moisture content is higher at the crawl space, condensation tends to accumulate on the insulation between the floor joists, which then exposes the floor assembly to moisture. We recommend to remove the insulation from the crawl space to help prevent moisture exposure to the floor assembly. Most of the floor assembly and some of the plumbing were not visible for inspection at the crawl space due to the insulation blocking the view.

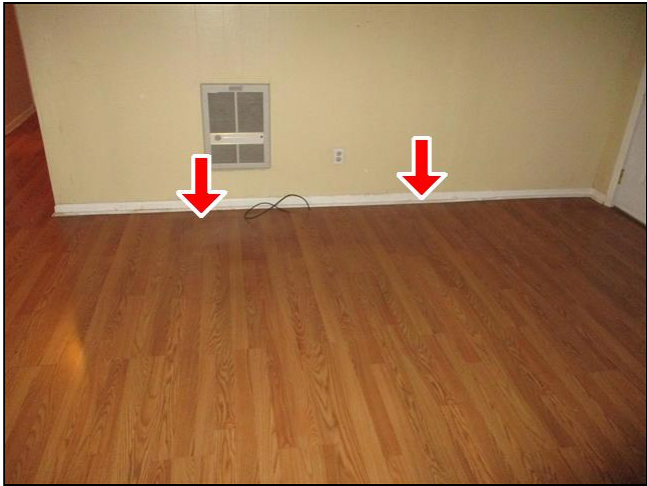
4.3 Item 3(Picture)

(3) The floor assembly appeared to have a dip next to one wall at the living room. This wall could potentially need better support from below. We recommend that a qualified contractor evaluate and make any needed repairs or replacements.

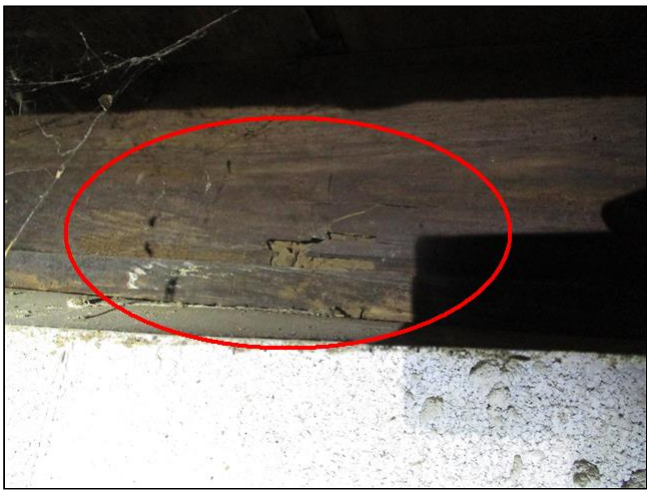
4.3 Item 4(Picture)

(4) The outer band joist and girder beam appeared to have some termite damage in one general area near the carport at the crawl space. We recommend that a qualified contractor evaluate and make any needed repairs or replacements.

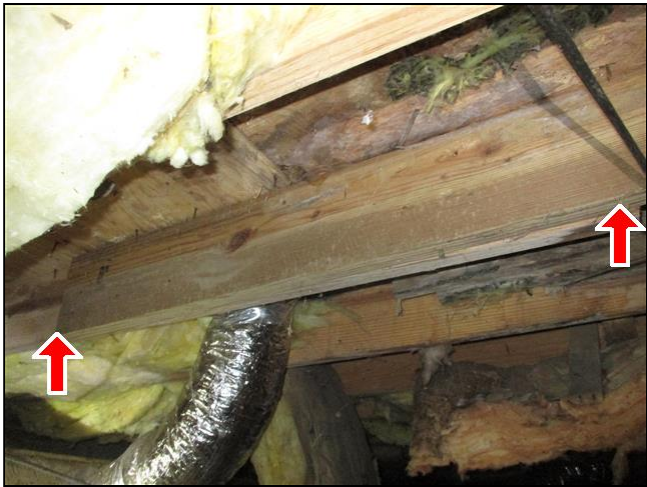
4.3 Item 7(Picture)

(5) One floor joist was spliced together and appeared to need bracing near the bathroom at the crawl space. Repair as needed.

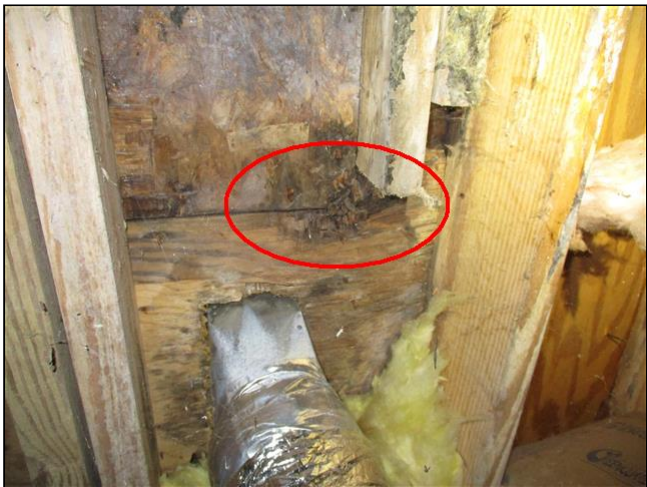
4.3 Item 8(Picture)

(6) The sub-flooring appeared to have some deterioration in two areas near the bathroom at the crawl space. We recommend that a qualified contractor evaluate and make any needed repairs or replacements.

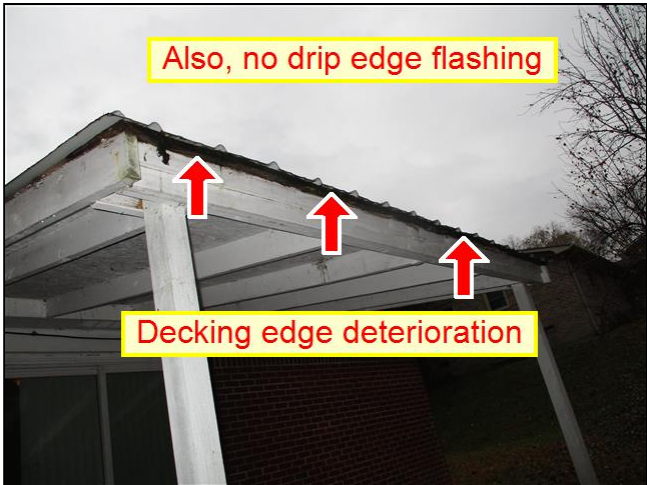
4.5 Item 1(Picture)

The plywood roof decking appeared to have some deterioration in areas overhead at the back porch.
Repair or replace as needed.

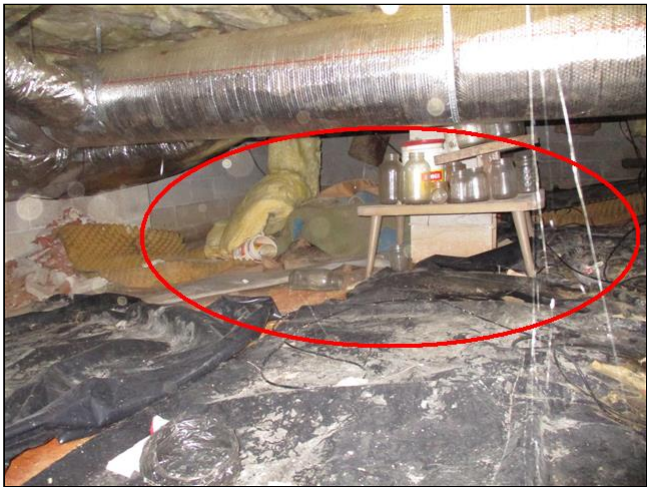
4.6 Item 1(Picture)

We recommend to remove any unneeded items/debris from the crawl space.

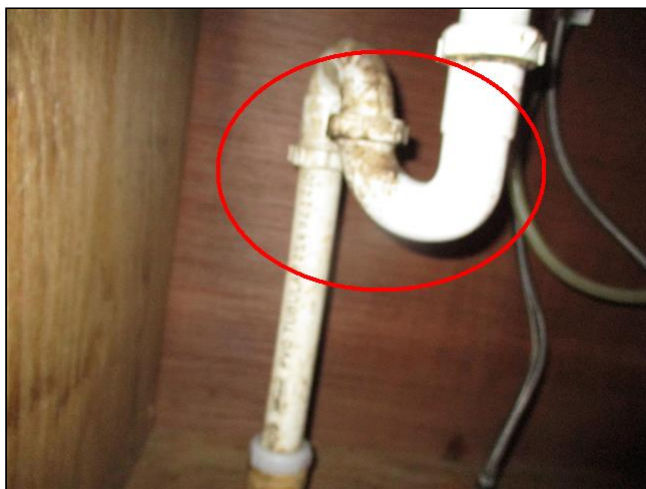
5.0 Item 1(Picture)

(1) It appeared that an s-trap was used on the drain line plumbing below the sink at the kitchen and bathroom. With an s-trap drain, the trap could potentially be siphoned dry with each use, which could allow sewer gases to enter the home. S-traps are common in older homes, but P-traps are used in most modern homes. If an s-trap gets siphoned dry, the trap can easily be filled by running more water down the drain. We recommend that a qualified plumbing contractor evaluate and make any needed repairs or replacements. S-traps are not considered a large concern.

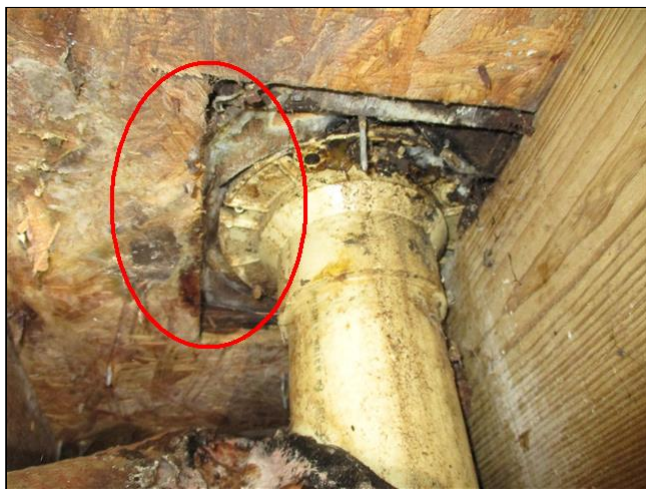
5.0 Item 2(Picture)

(2) It appeared that the toilet may have a bad seal. Water was dripping below the toilet at the crawl space. Repair or replace as needed.

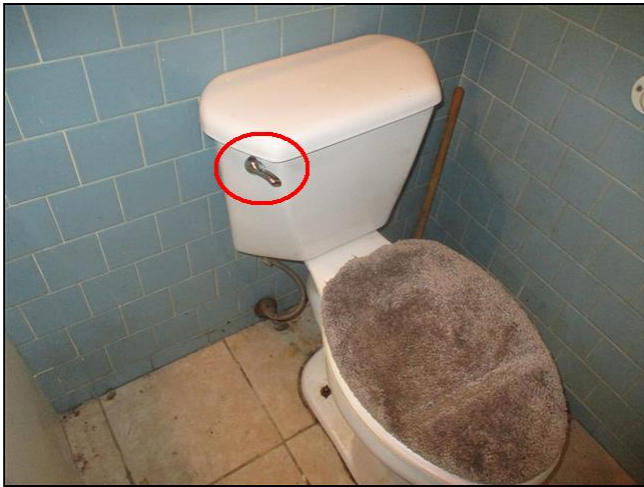
5.1 Item 4(Picture)

(4) It appeared that the flush handle on the toilet was not secured well. Also, the toilet was running. Repair or replace as needed.

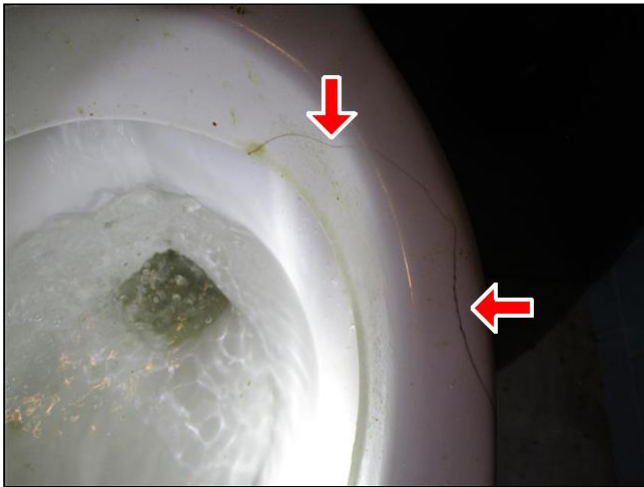
5.1 Item 5(Picture)

(5) The toilet bowl appeared to be cracked. Replace as needed.

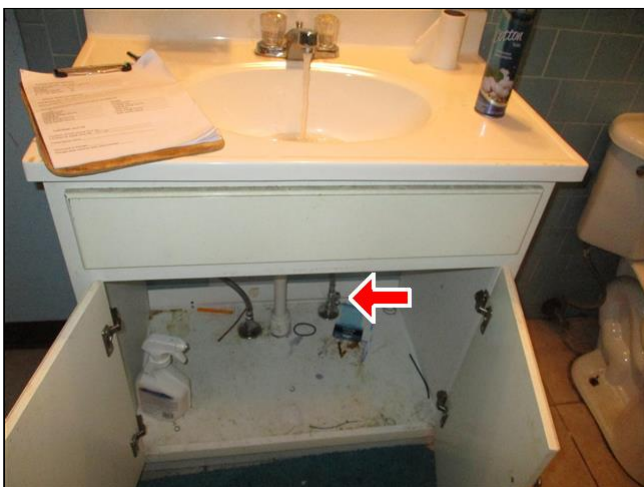
5.1 Item 7(Picture)

(6) One water valve was turned off for some reason below the vanity sink at the bathroom. We recommend further evaluation.

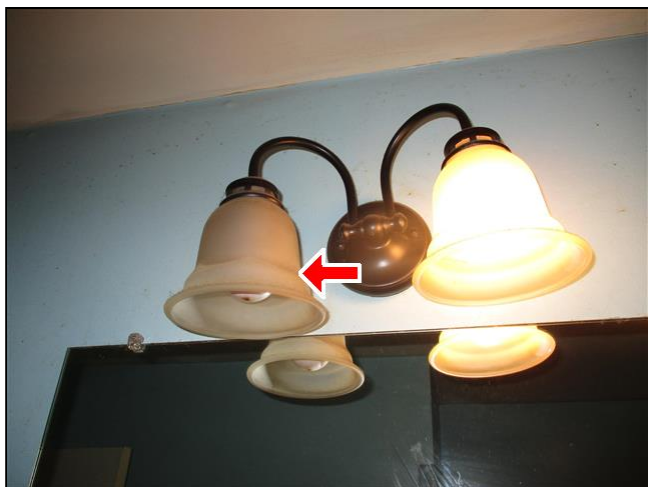
6.3 Item 1(Picture)

(1) One bulb appeared to be out or the light fixture may not function properly at the bathroom. We recommend to replace the bulb, then re-inspect the light fixture.

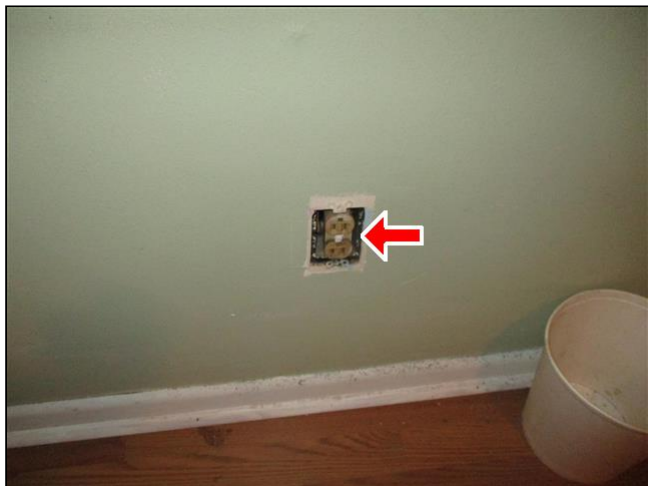
6.3 Item 2(Picture)

(2) A few of the outlet covers were missing in the home. Replace for safety enhancement.

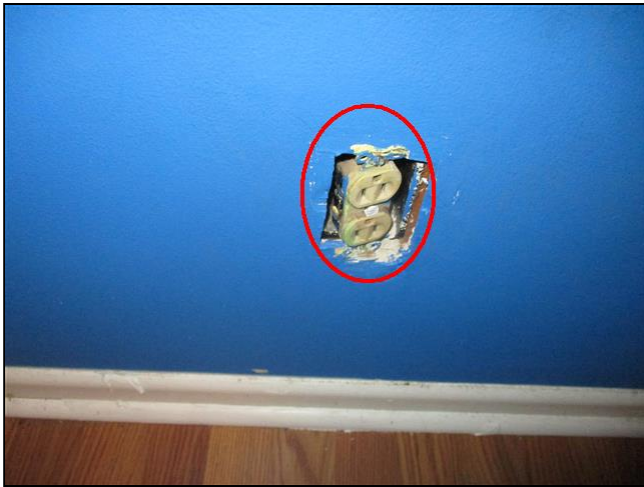
6.3 Item 5(Picture)

(3) It appeared that one receptacle was not secured well at the front corner bedroom. Repair or replace as needed.

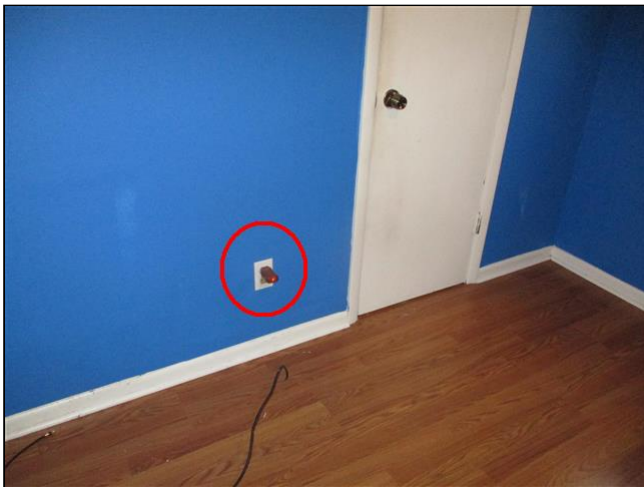
6.4 Item 1(Picture)

One receptacle showed open ground at the front corner bedroom. Repair as needed.

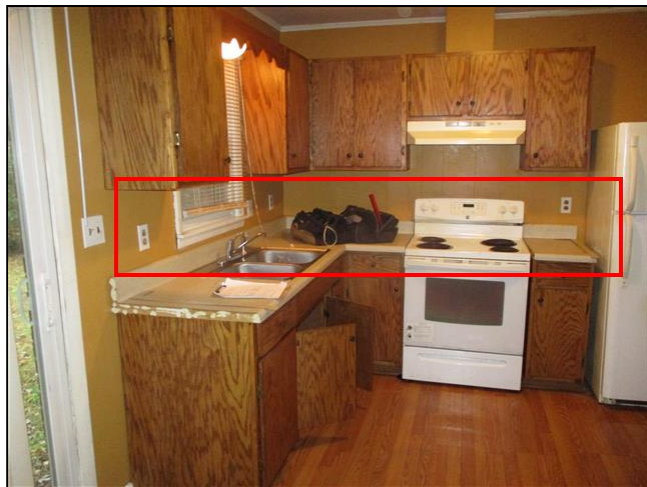
6.5 Item 1(Picture)

The receptacles appeared to have no GFCI protection at the laundry room, kitchen countertops and bathroom. We recommend that these receptacles have GFCI protection for safety enhancement. It is generally recommended that readily accessible receptacles within 6ft of wet areas have GFCI protection except for when dedicated non-GFCI protected circuits are needed. A GFCI outlet is an electrical outlet which is designed to protect people from deadly electric shock.

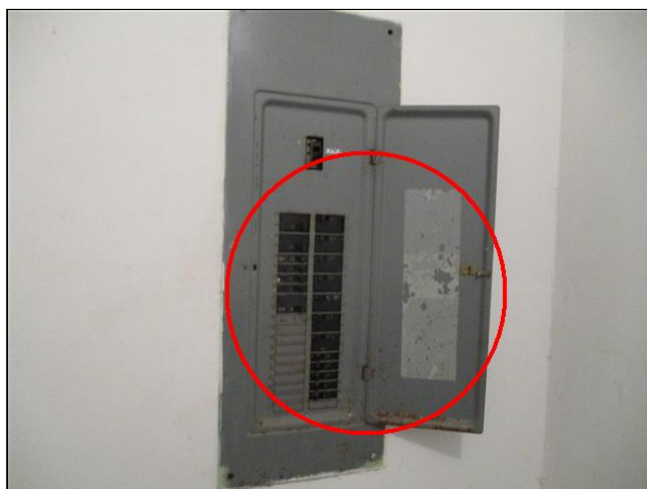
6.8 Item 1(Picture)

We recommend to label all circuit breakers.

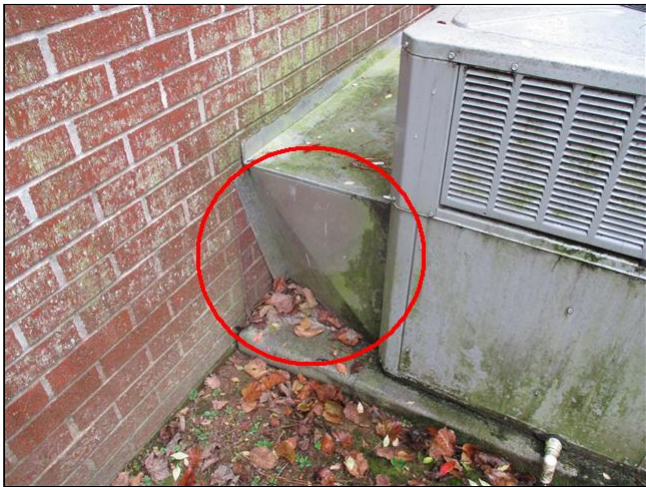
7.2 Item 1(Picture)

(1) The exterior HVAC hood appeared to be bent. Repair or replace as needed.

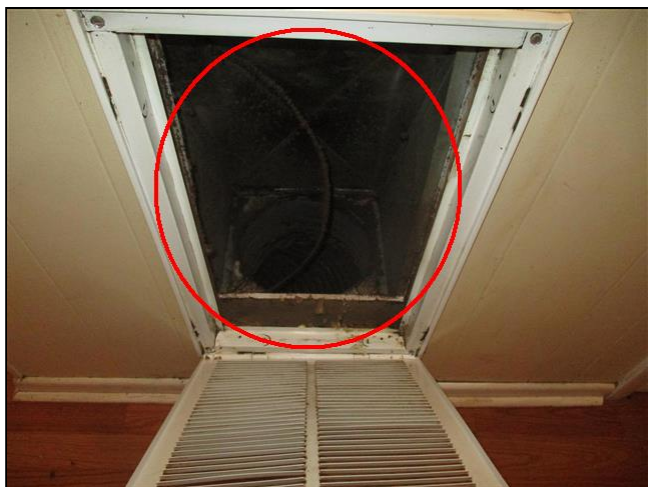
7.2 Item 2(Picture)

(2) The air filter appeared to be missing. Replace.

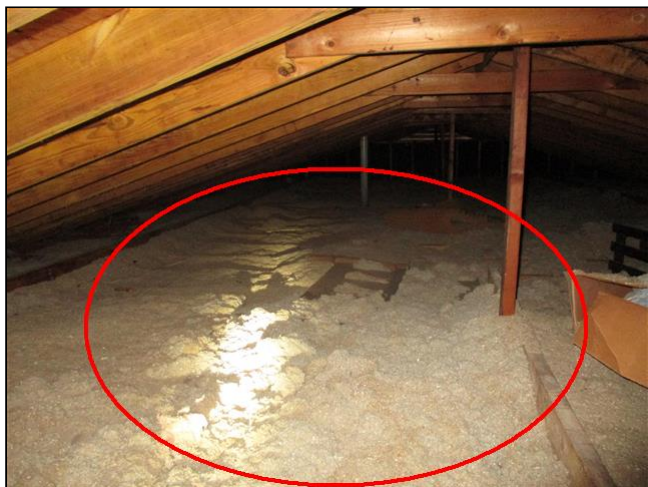
8.0 Item 1(Picture)

The insulation appeared to be low in most areas at the attic floor. We recommend that a qualified insulation contractor evaluate and add insulation as needed to help prevent energy loss.

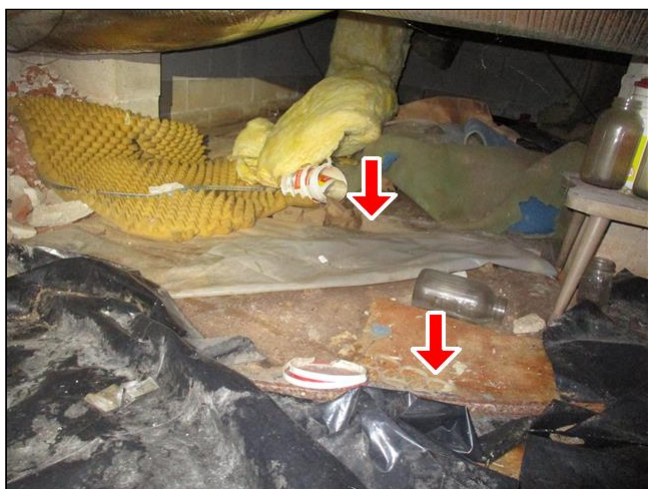
8.1 Item 1(Picture)

The plastic vapor retarder appeared to be missing in one area on the crawl space floor. The plastic vapor retarder resists diffusion of moisture from the dirt floor of the crawlspace. We recommend that all of the bare dirt floor be covered, we recommend to use 6mil or thicker black plastic, and we recommend that all seams overlap at least 6".

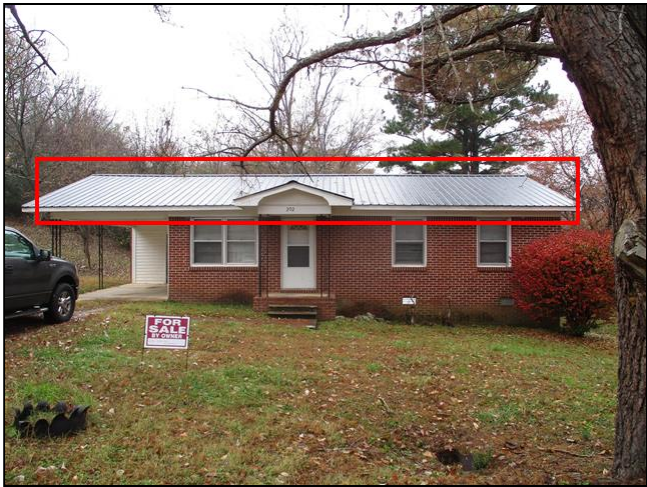
8.2 Item 1(Picture)

It appeared that the attic needs more ventilation. Roof vents and/or a power ventilation fan could be installed for more ventilation. Repair as needed. The attic appeared to have soffit and gable ventilation.

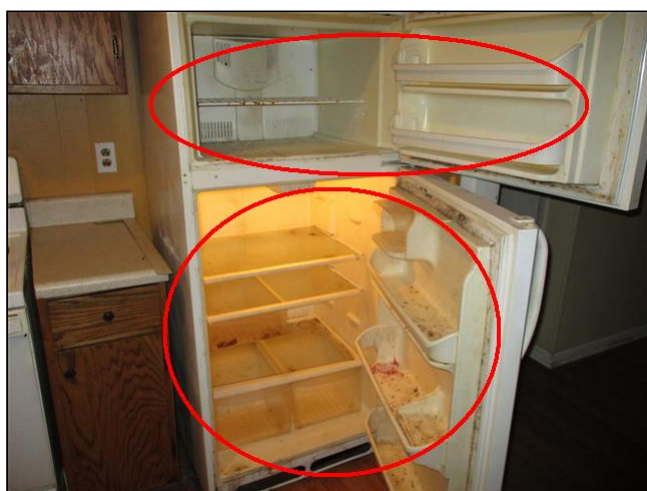
9.2 Item 1(Picture)

We noted what appeared to be fungal growth present inside the refrigerator and freezer. We recommend that a qualified individual evaluate and treat/remove as needed. Also, the refrigerator was turned off upon our arrival. The freezer and refrigerator were cooling down before we left the inspection.

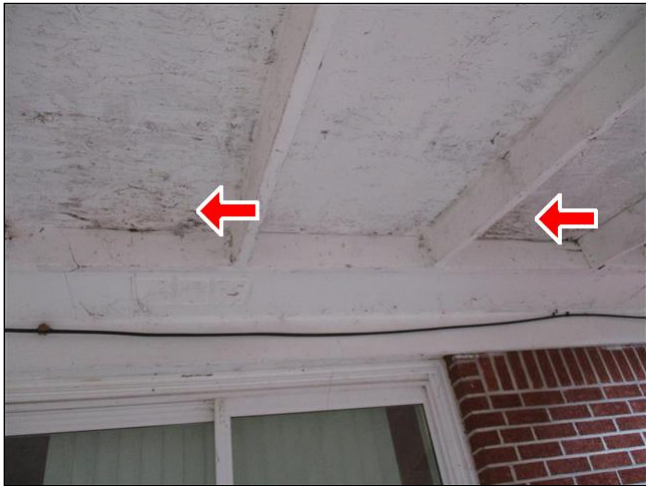
1.0 Item 1(Picture)

The plywood roof decking had some deterioration in areas at the back porch. The deterioration could potentially be the result of an active or past leak. Repair or replace as needed.

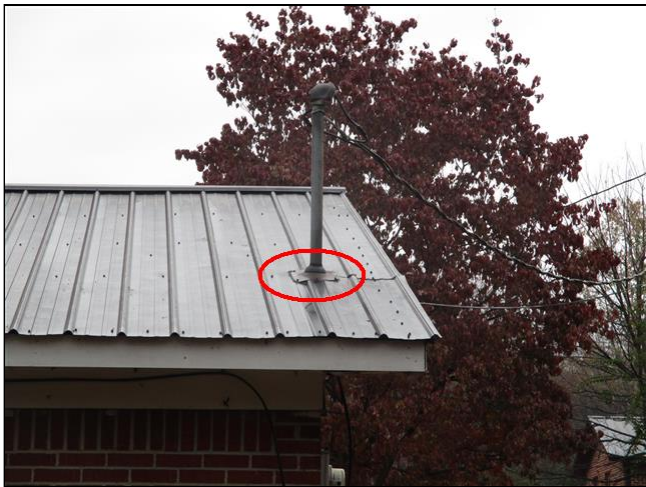
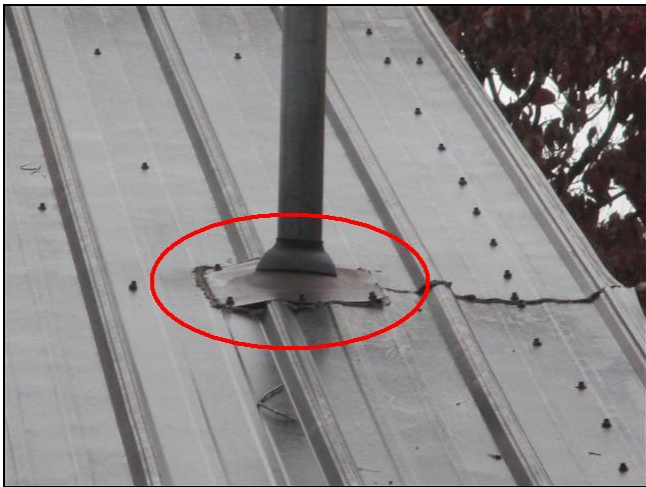
(2) It appeared that the wrong type of boot/flashings was used around the base of the electric mast at the roof. Replace as needed.

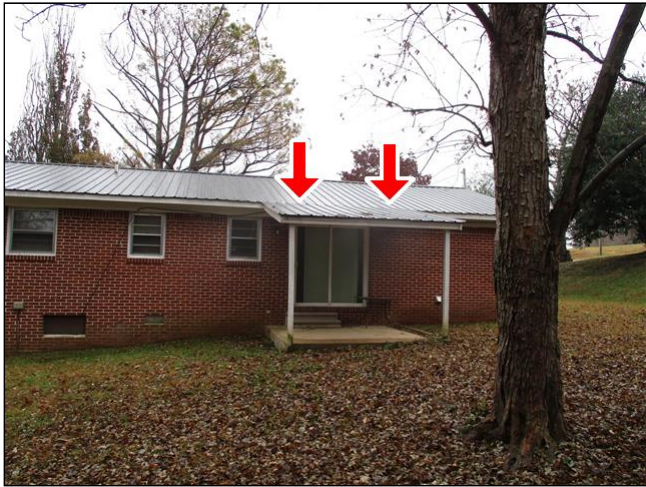
1.1 Item 4(Picture)

(3) It appeared that transition flashing was not installed where the roof pitch changes at the back of the home. Transition flashing helps prevent water intrusion. We recommend that a qualified roofing contractor evaluate and make any needed repairs or replacements.

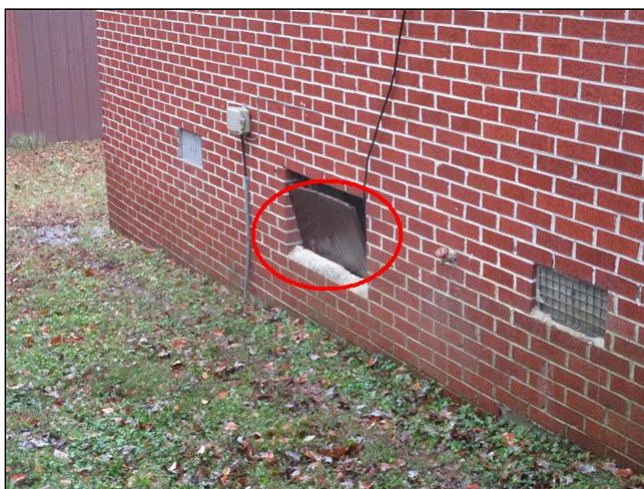
2.1 Item 3(Picture)

(2) The crawl space door would not latch/stay in place. Repair or replace as needed.

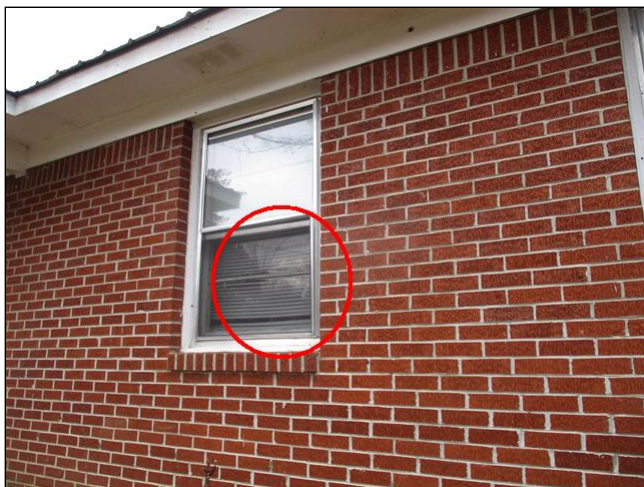
2.2 Item 1(Picture)

(1) It appeared that one screen was not secured well on one window at the front of the home. Also, it appeared that two or more of the window screens were missing. Repair or replace as needed.

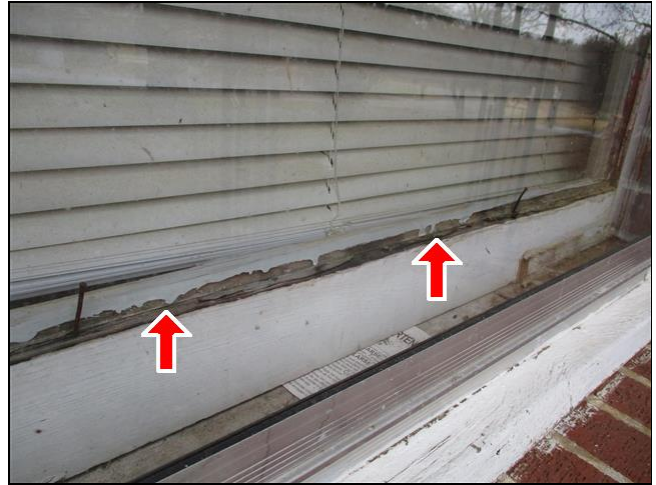
2.2 Item 3(Picture)

(2) The exterior window glazing compound appeared to be deteriorated/loose/missing on some windows. Repair or replace as needed.

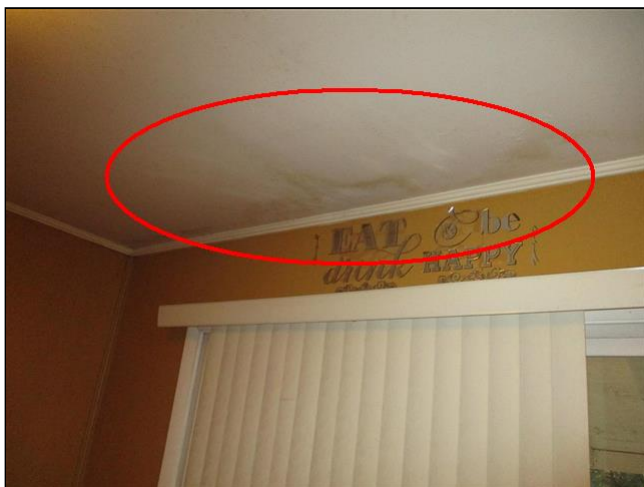
3.0 Item 1(Picture)

The ceiling revealed a stain at the kitchen and bathroom. The stains could potentially be the result of an active or past leak. We recommend further evaluation by a qualified contractor.

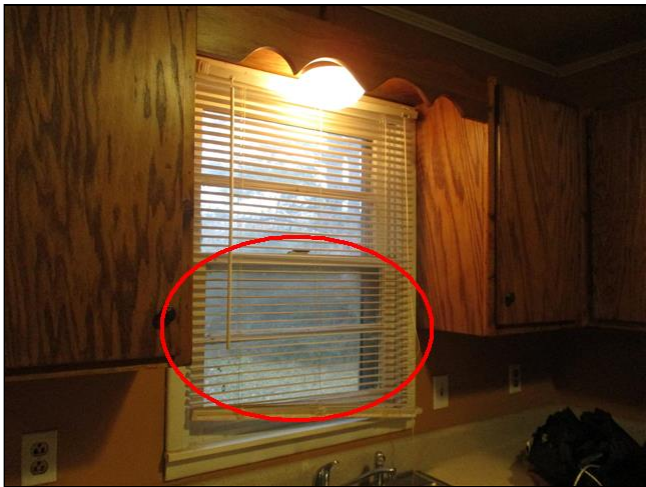
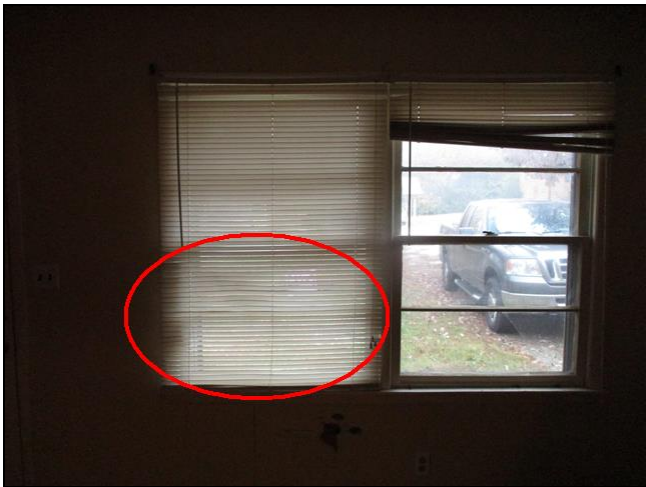
(1) We were unable to get the window to open at the kitchen and one at the living room. Repair or replace as needed.

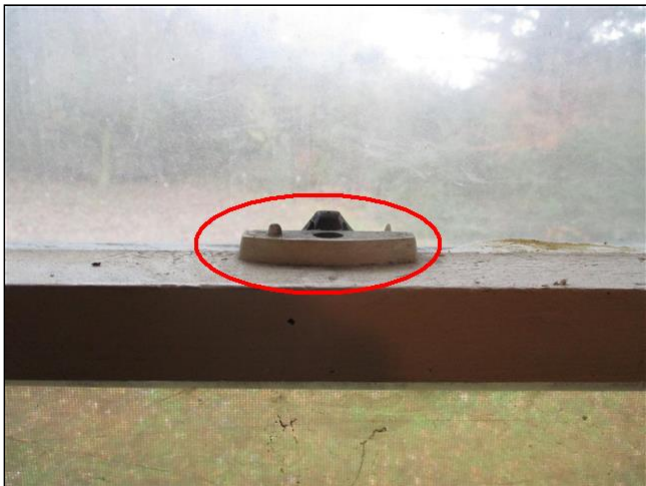
3.5 Item 3(Picture)

(2) The latch appeared to be missing/damaged on one window at the back corner bedroom. Repair or replace as needed.

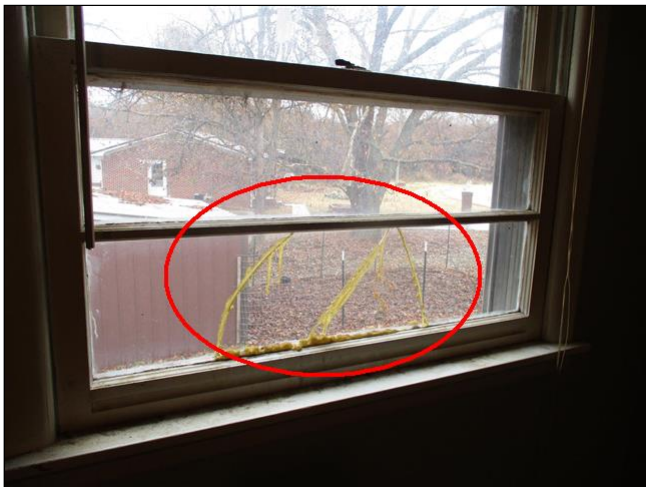
3.5 Item 4(Picture)

(3) The glass pane appeared to be damaged on one window at the back corner bedroom, the window at the front middle bedroom and one window at the living room. Repair or replace as needed.

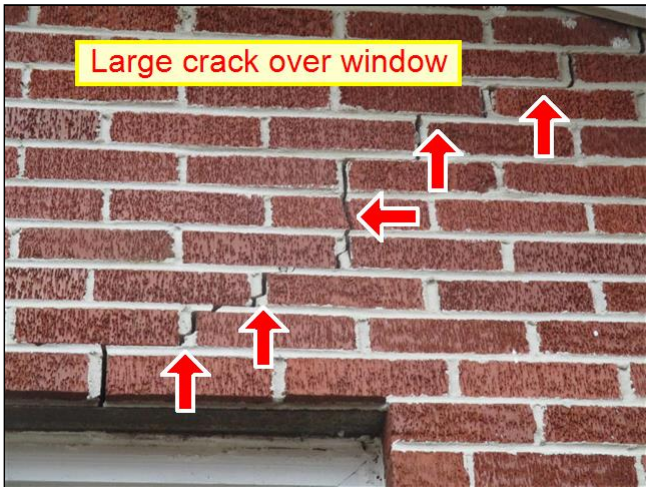
4.0 Item 1(Picture)

(1) The exterior brick wall cladding revealed cracks indicating movement near one window at the gable on the right side of the home. Also, the masonry block foundation wall revealed cracks along the mortar joints indicating movement on this same end of the home at the crawl space. We recommend that a qualified contractor evaluate and make any needed repairs or replacements.

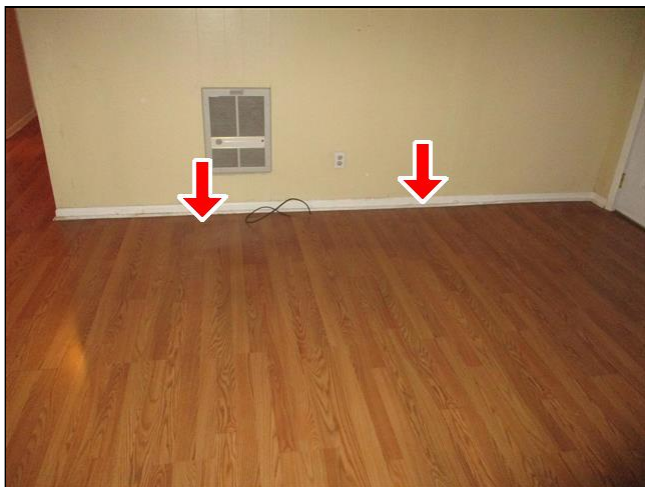
4.3 Item 3(Picture)

(3) The floor assembly appeared to have a dip next to one wall at the living room. This wall could potentially need better support from below. We recommend that a qualified contractor evaluate and make any needed repairs or replacements.

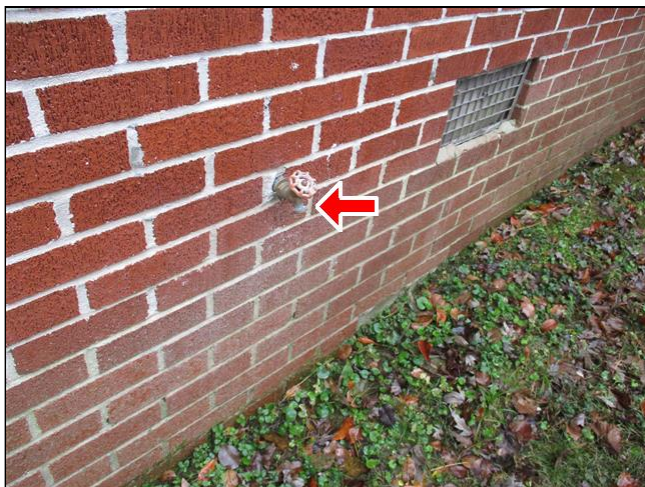
5.1 Item 1(Picture)

(1) With the water turned off, water was dripping from the exterior water spigot at the back of the home. Repair or replace as needed.

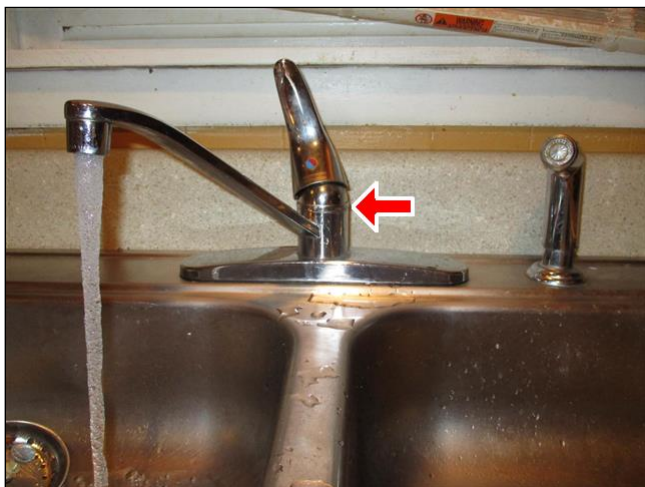
5.1 Item 3(Picture)

(3) The kitchen sink faucet appeared to leak when turning the faucet from side to side. Repair or replace as needed.

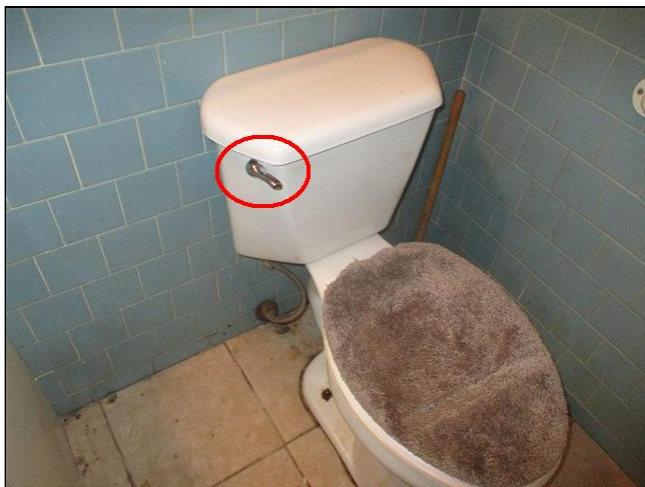
5.1 Item 4(Picture)

(4) It appeared that the flush handle on the toilet was not secured well. Also, the toilet was running. Repair or replace as needed.

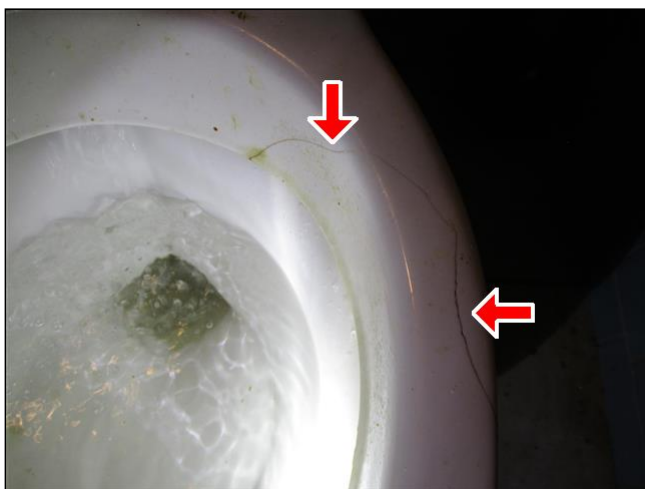
5.1 Item 5(Picture)

(5) The toilet bowl appeared to be cracked. Replace as needed.

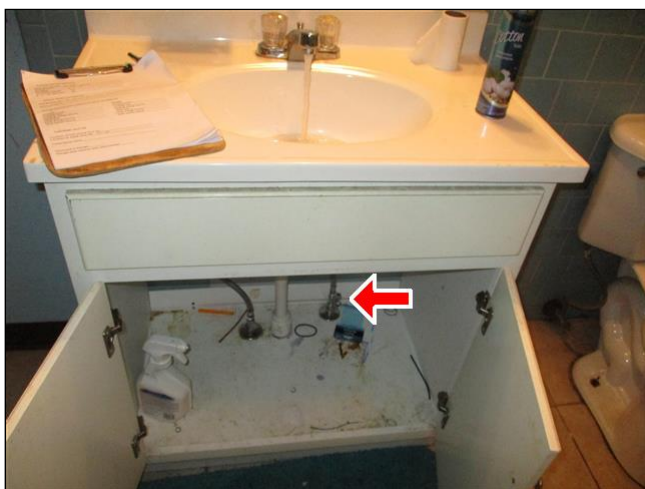
5.1 Item 7(Picture)

(6) One water valve was turned off for some reason below the vanity sink at the bathroom. We recommend further evaluation.

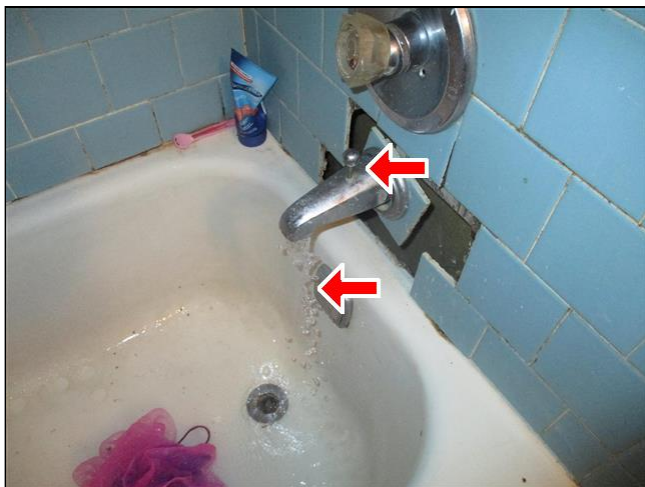
5.1 Item 8(Picture)

(7) The shower diverter appeared to not function properly at the bathroom. Some water was still flowing from the spout with the diverter engaged. Repair or replace as needed.

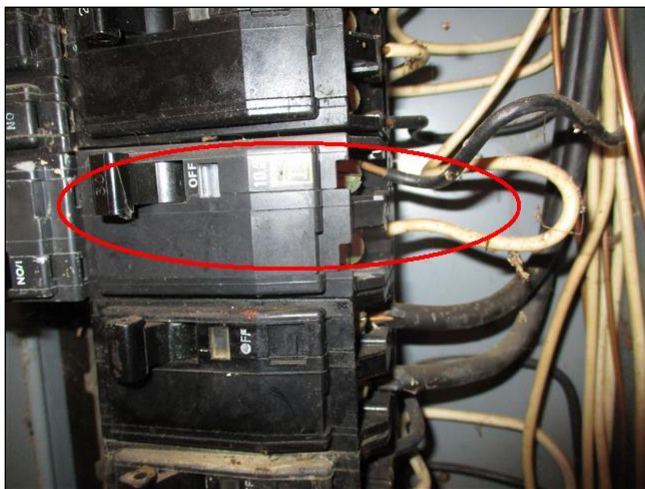
6.2 Item 1(Picture)

The branch circuit wiring may not be compatible with one circuit breaker inside the electric service panel. It appeared that a 30amp circuit breaker was used with 12gauge wiring on one circuit. The circuit breaker may be oversized for the gauge of wiring. We recommend further evaluation by a qualified electrical contractor.

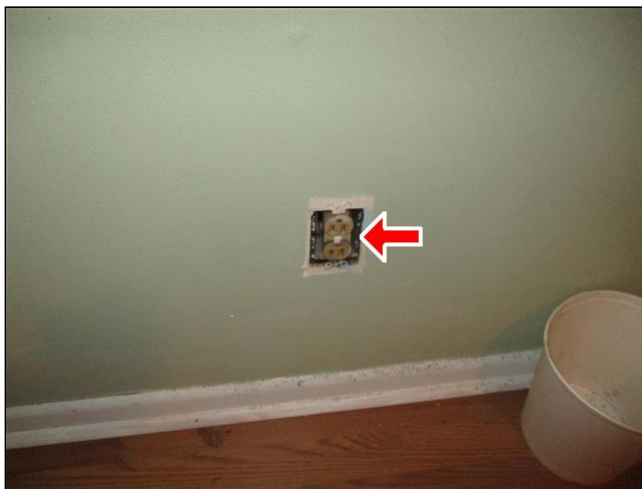
6.3 Item 2(Picture)

(2) A few of the outlet covers were missing in the home. Replace for safety enhancement.

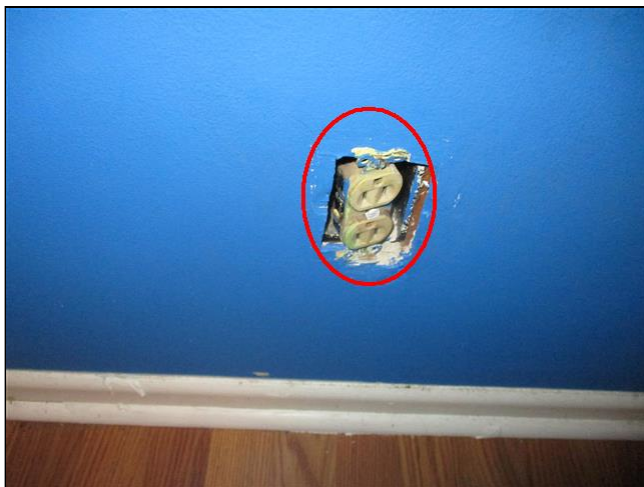
6.3 Item 5(Picture)

(3) It appeared that one receptacle was not secured well at the front corner bedroom. Repair or replace as needed.

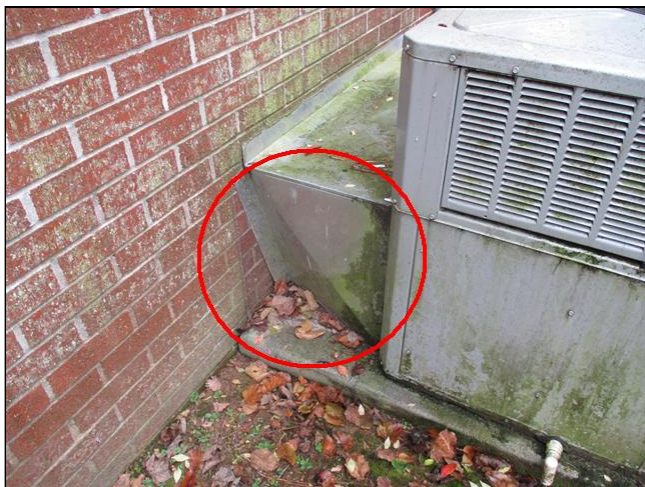
7.2 Item 1(Picture)

(1) The exterior HVAC hood appeared to be bent. Repair or replace as needed.

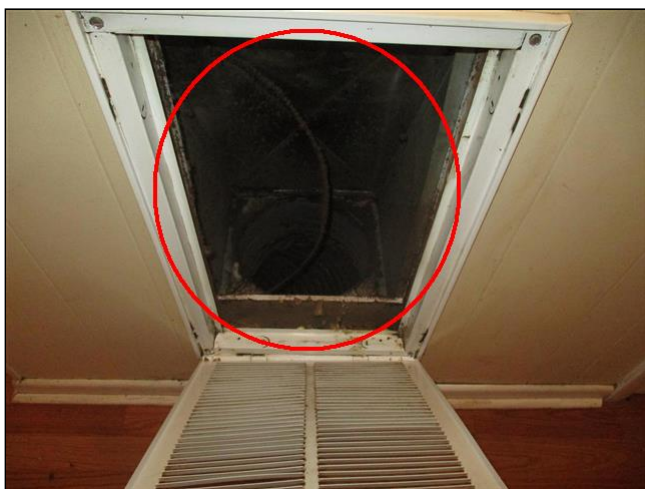
7.2 Item 2(Picture)

(2) The air filter appeared to be missing. Replace.

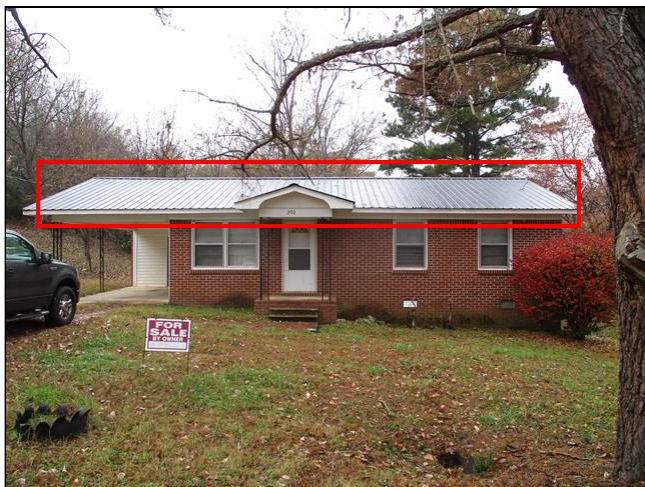
8.2 Item 1(Picture)

It appeared that the attic needs more ventilation. Roof vents and/or a power ventilation fan could be installed for more ventilation. Repair as needed. The attic appeared to have soffit and gable ventilation.
