Inspection Report

Property Address:
307 Hidden Drive
Winchester TN 37398

Belmar Home Inspections

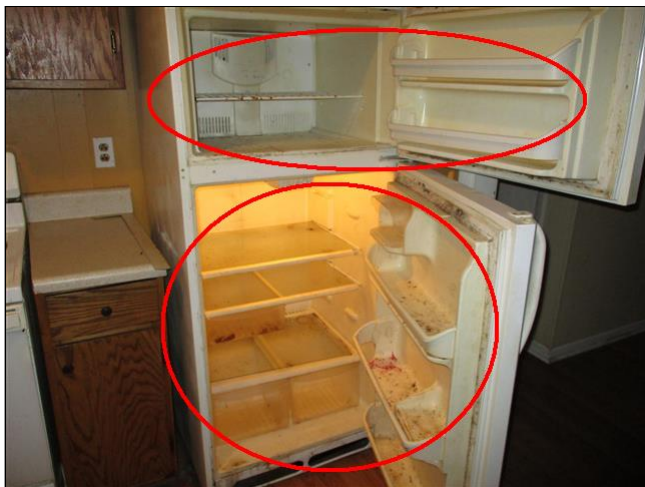
9.2 Item 1(Picture)

We noted what appeared to be fungal growth present inside the refrigerator and freezer. We recommend that a qualified individual evaluate and treat/remove as needed. Also, the refrigerator was turned off upon our arrival. The freezer and refrigerator were cooling down before we left the inspection.
