Inspection Report

Property Address:
307 Hidden Drive
Winchester TN 37398

Belmar Home Inspections

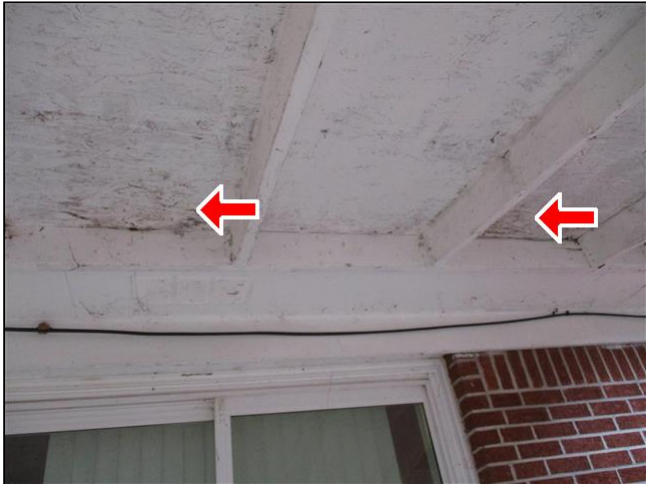
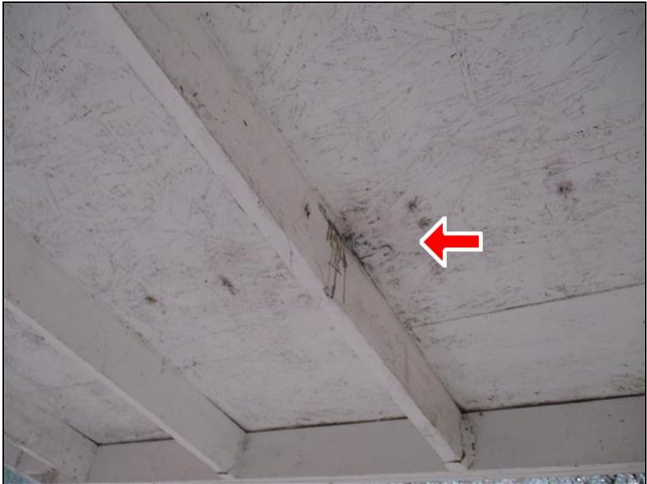
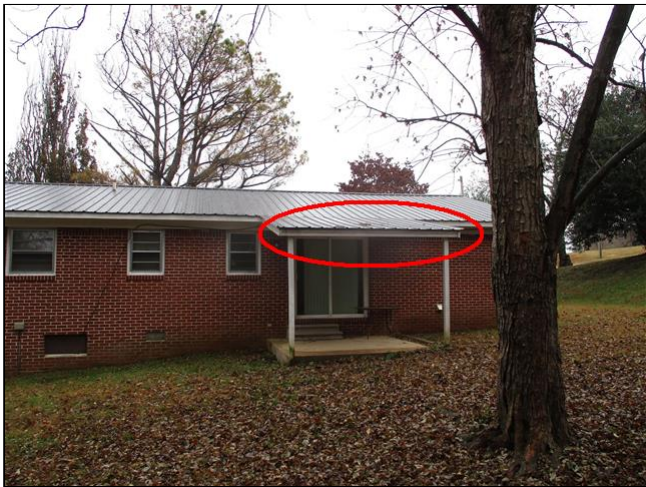
The plywood roof decking had some deterioration in areas at the back porch. The deterioration could potentially be the result of an active or past leak. Repair or replace as needed.

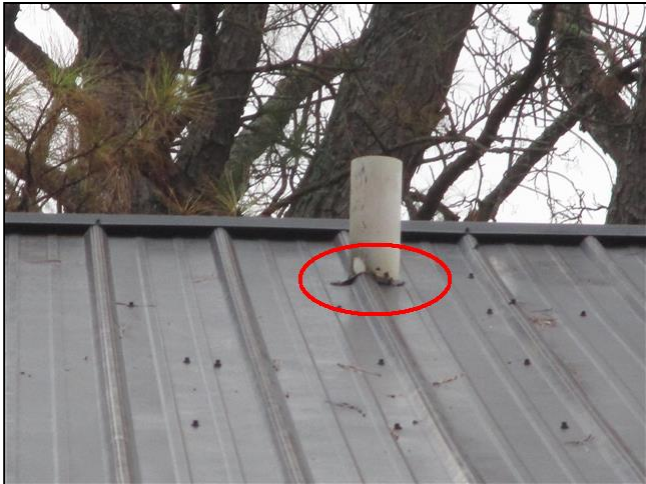
1.1 Item 1(Picture)

(1) It appeared that caulking/sealant was used for flashing around the base of the plumbing vent at the roof. Caulking/sealant can crack/separate potentially leaving an open gap for water intrusion. We recommend that a proper boot flashing be installed to help prevent water intrusion.

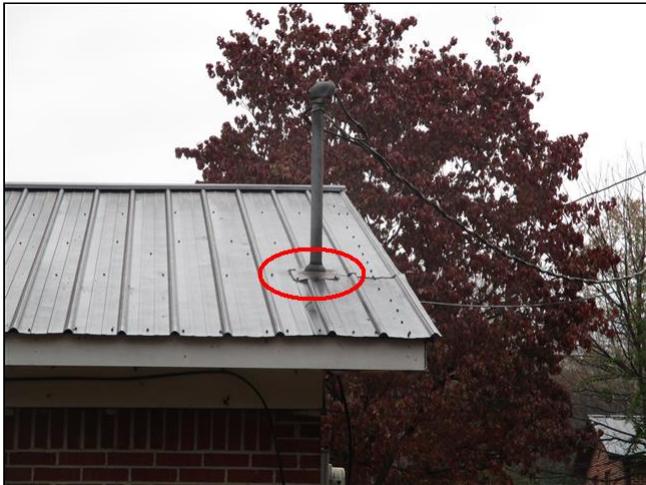
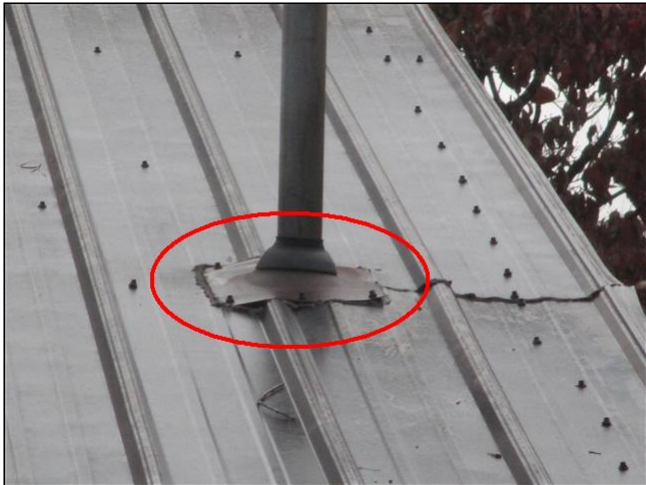
(2) It appeared that the wrong type of boot/flashing was used around the base of the electric mast at the roof. Replace as needed.

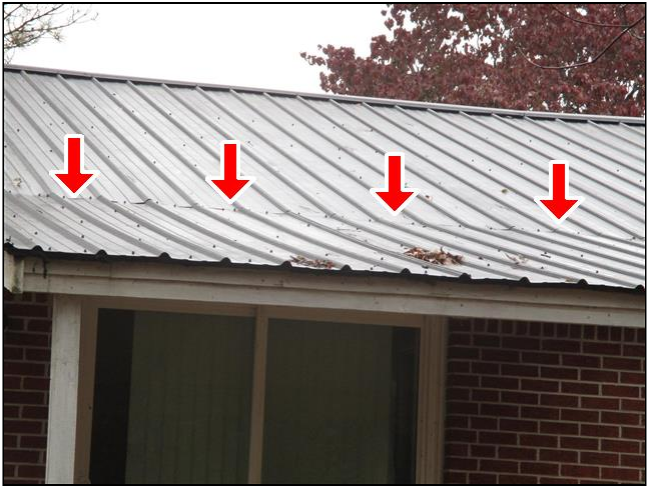
1.1 Item 5(Picture)

(3) It appeared that transition flashing was not installed where the roof pitch changes at the back of the home. Transition flashing helps prevent water intrusion. We recommend that a qualified roofing contractor evaluate and make any needed repairs or replacements.

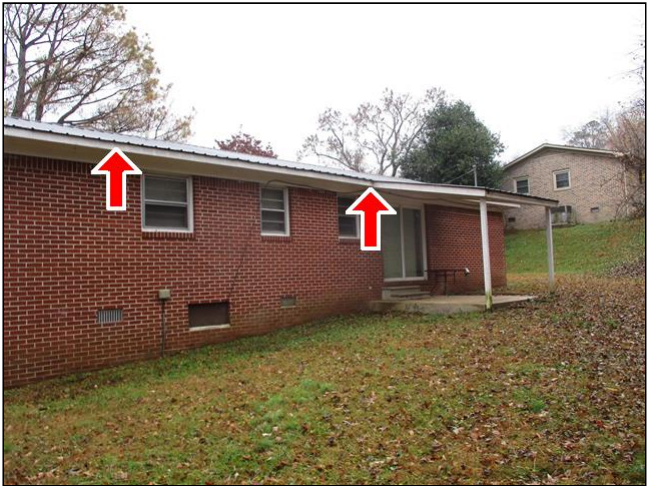
1.2 Item 2(Picture)

It appeared that gutters and downspouts were not present on the home. We recommend to install gutters and downspouts to help divert water away from the foundation.

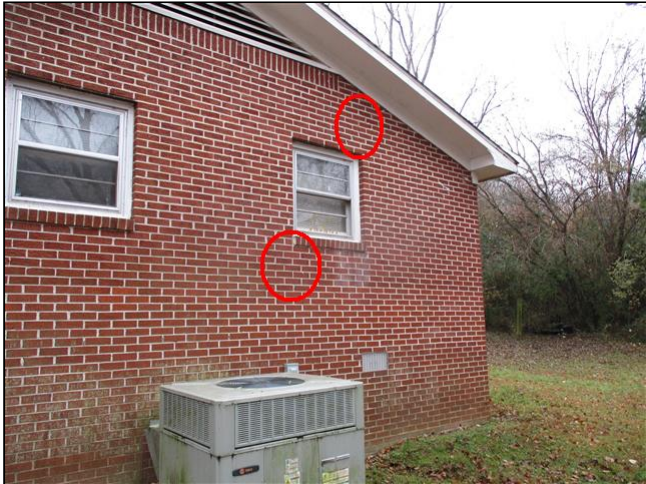
2.0 Item 1(Picture)

The exterior brick wall cladding revealed cracks indicating movement at the gable end on the right side of the home. We recommend that a qualified contractor evaluate and make any needed repairs or replacements. We noted these cracks in the foundation section of the report also.

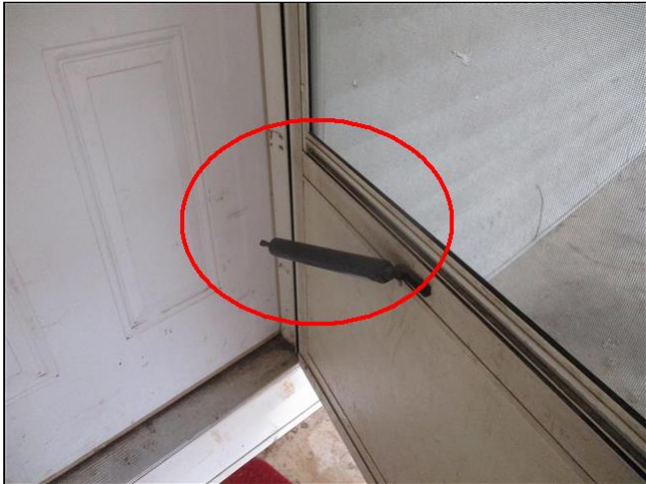
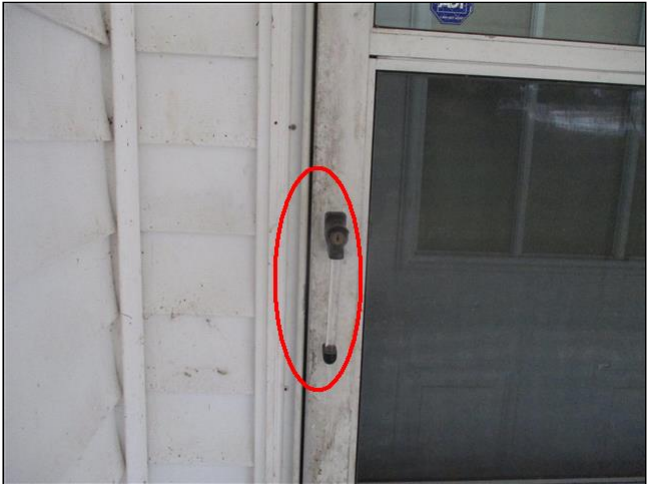
(1) The pneumatic door closer on the storm door appeared to be detached at the carport. Also, this door would not latch and the handle appeared to be damaged. Repair or replace as needed.

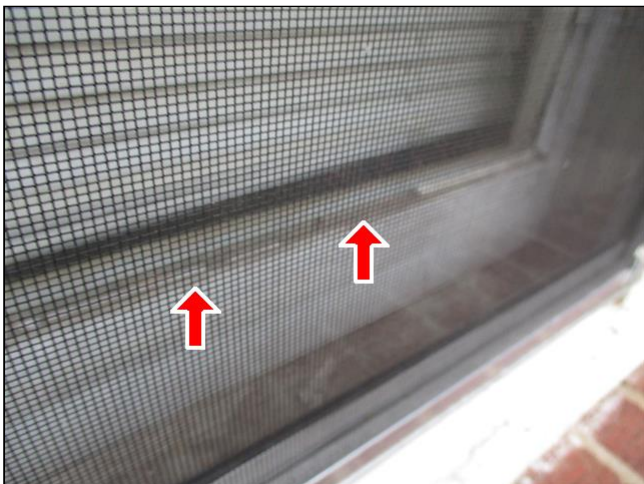
2.2 Item 2(Picture)

(2) The exterior window glazing compound appeared to be deteriorated/loose/missing on some windows. Repair or replace as needed.

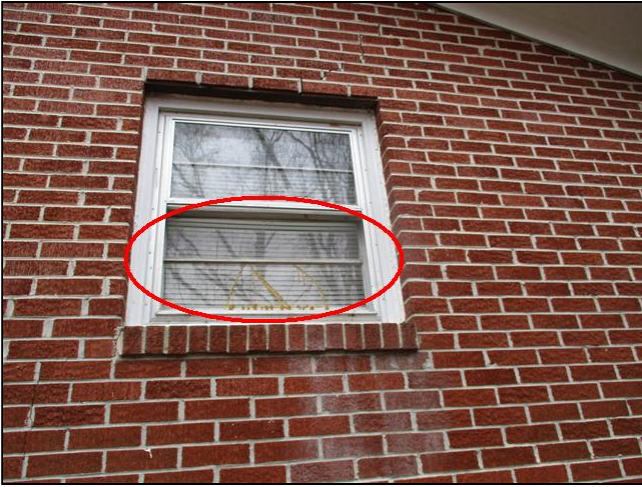
2.2 Item 4(Picture)

(3) One storm window pane appeared to be missing at the gable end on the right side of the home. Replace as needed.

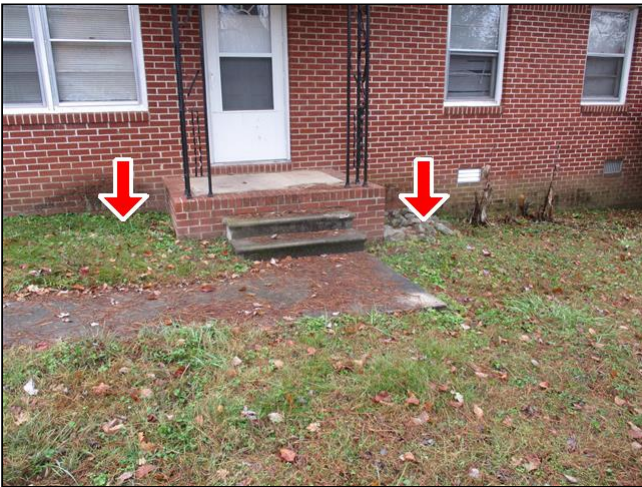
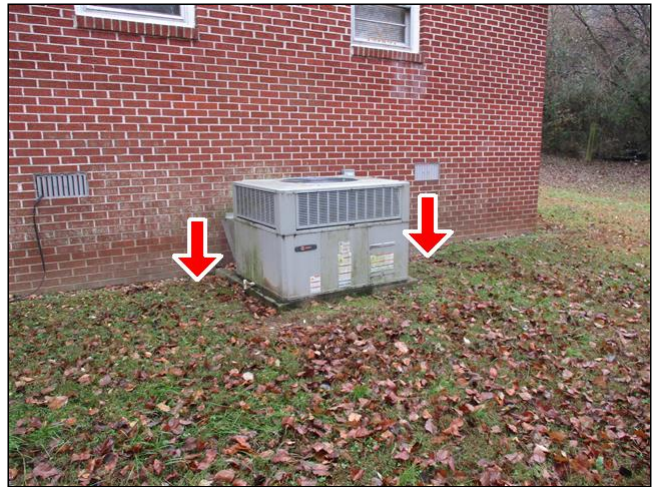
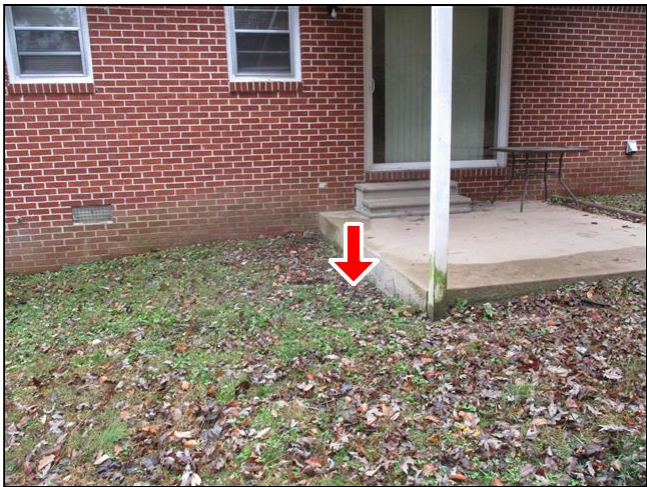
The yard appeared to be low in areas near the home. It is recommended that the yard have a positive slope away from the home in all areas if possible to help divert water away from the foundation. Repair as needed.

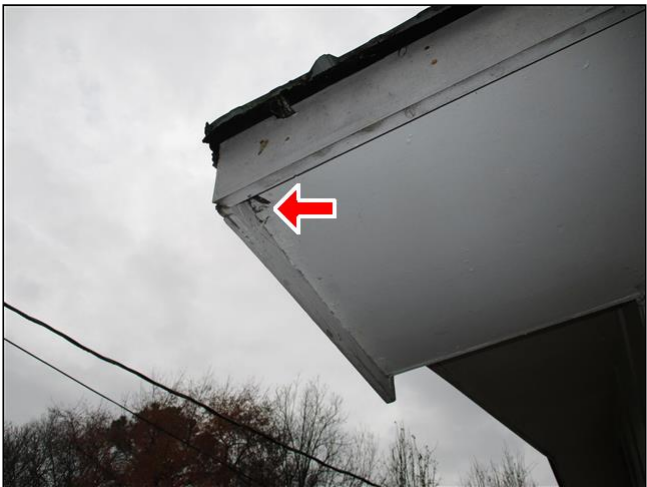
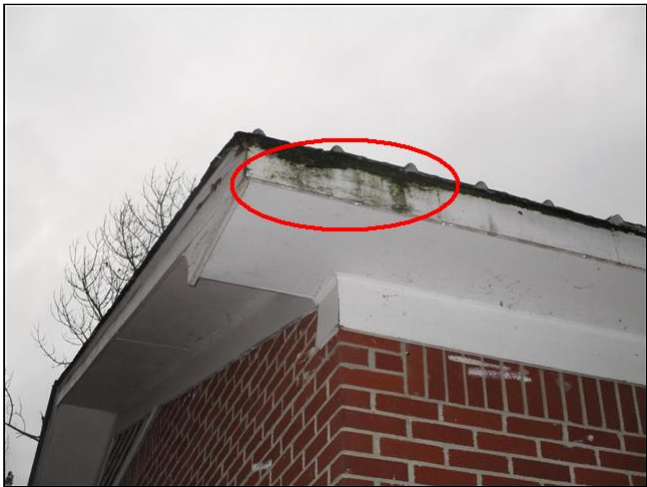
We noted what appeared to be deterioration/water damage along the eaves in a few areas around the home. Repair or replace as needed.

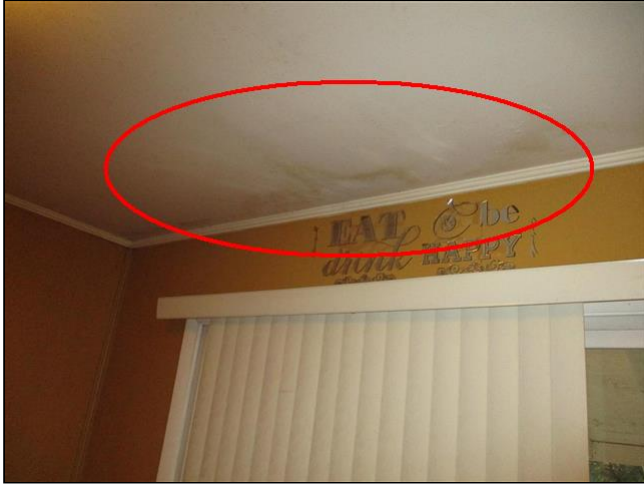
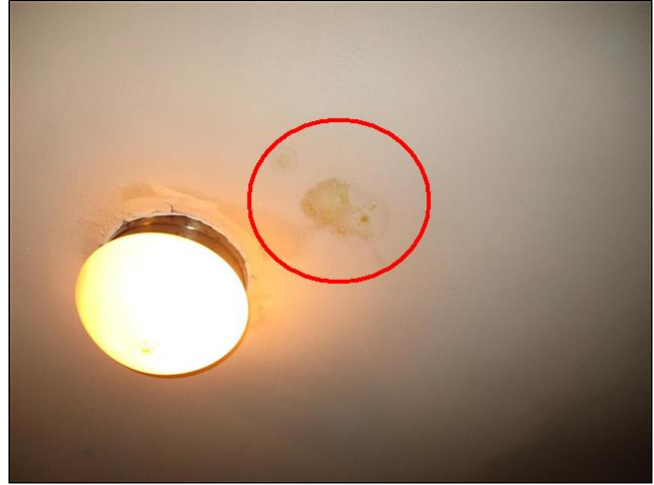
The ceiling revealed a stain at the kitchen and bathroom. The stains could potentially be the result of an active or past leak. We recommend further evaluation by a qualified contractor.

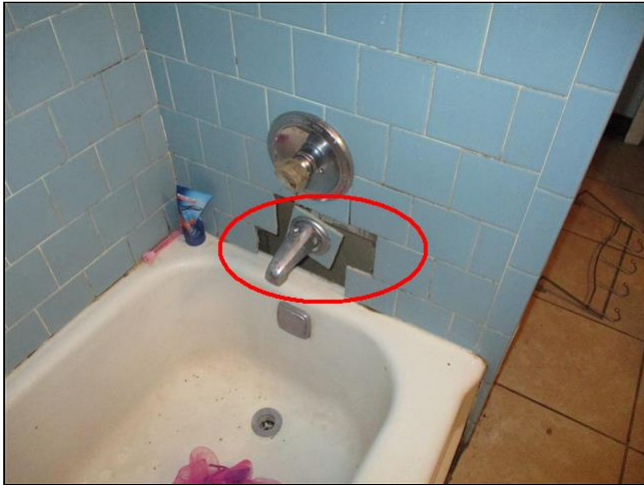
3.1 Item 1(Picture)

The wall tiles appeared to be damaged/missing in one general area inside the shower. Repair or replace as needed.

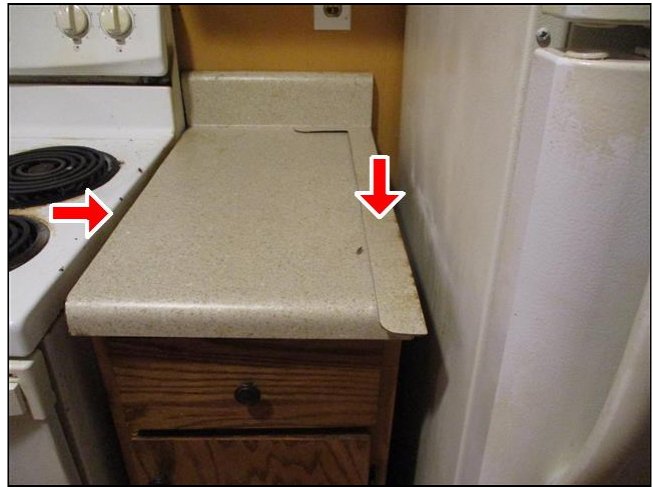
3.3 Item 2(Picture)

The laminate end caps for the countertops appeared to be detached at the kitchen. Repair or replace as needed.

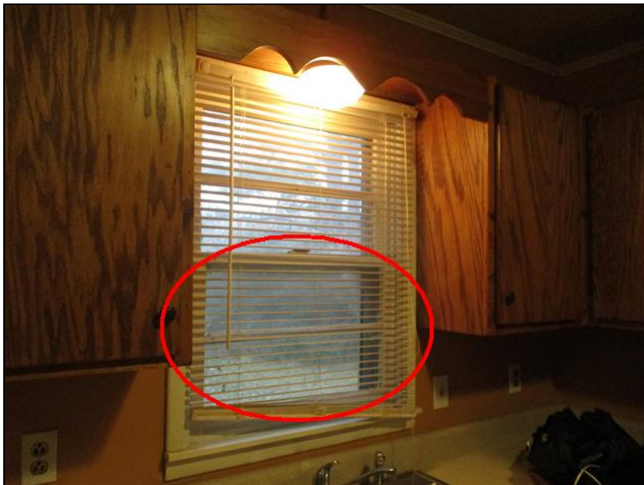
3.5 Item 1(Picture)

(1) We were unable to get the window to open at the kitchen and one at the living room. Repair or replace as needed.

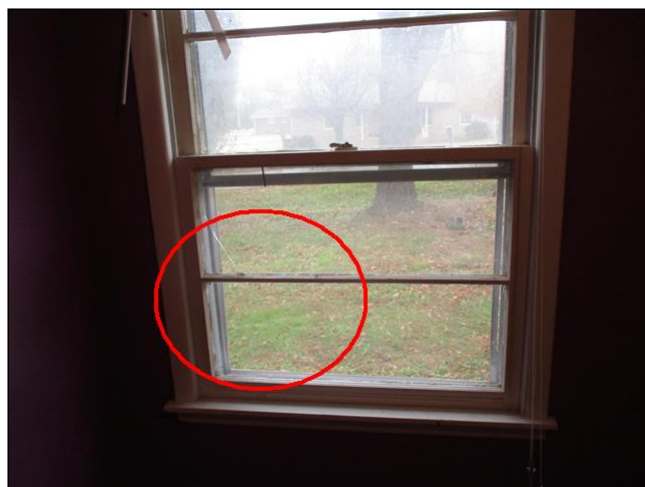
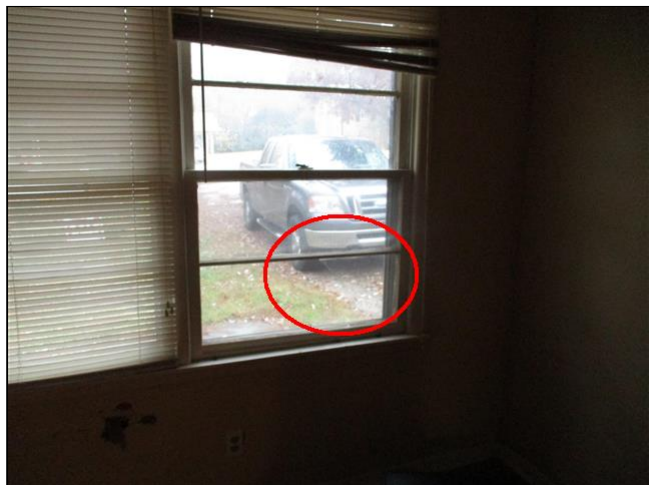
(3) The glass pane appeared to be damaged on one window at the back corner bedroom, the window at the front middle bedroom and one window at the living room. Repair or replace as needed.

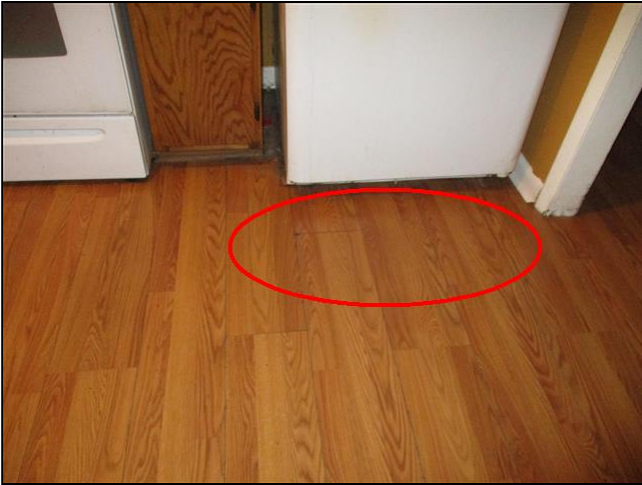
3.6 Item 1(Picture)

The floor covering appeared as though it may have had some moisture exposure in the past near the refrigerator at the kitchen.

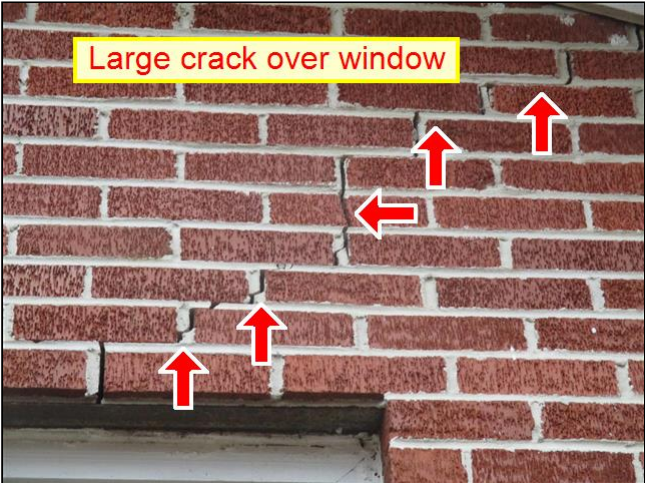
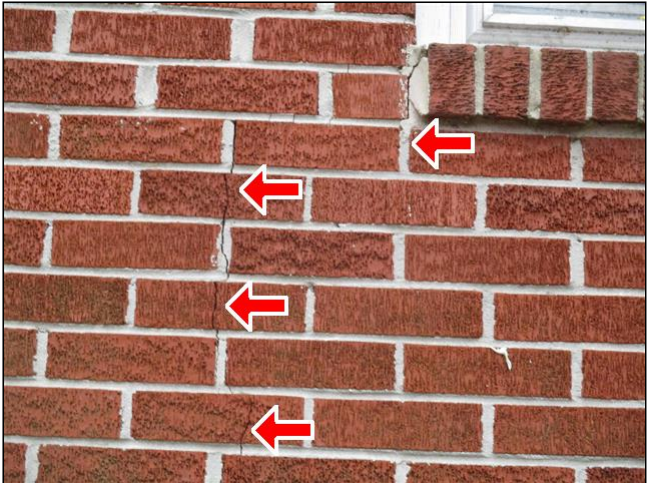
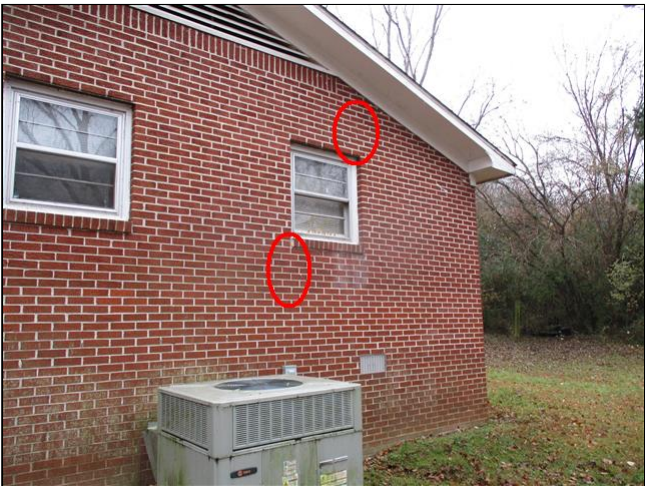
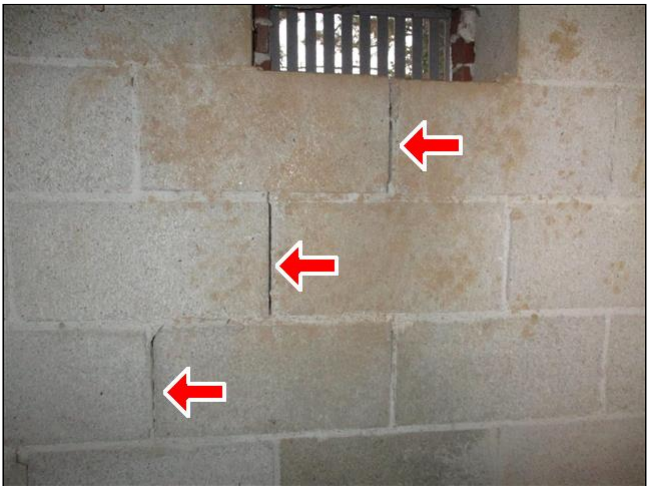
(1) The exterior brick wall cladding revealed cracks indicating movement near one window at the gable on the right side of the home. Also, the masonry block foundation wall revealed cracks along the mortar joints indicating movement on this same end of the home at the crawl space. We recommend that a qualified contractor evaluate and make any needed repairs or replacements.

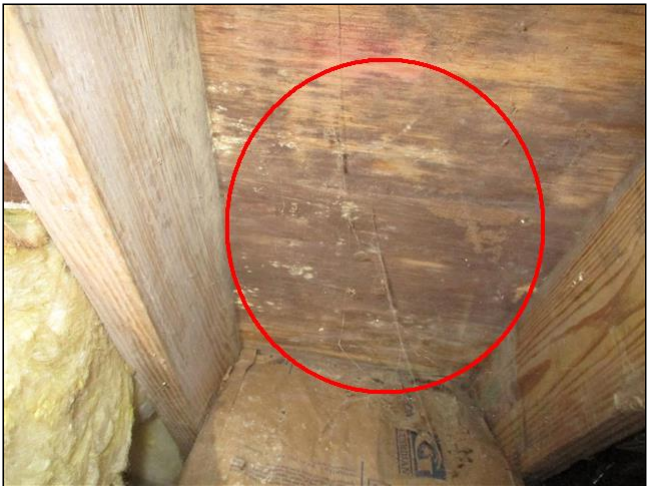
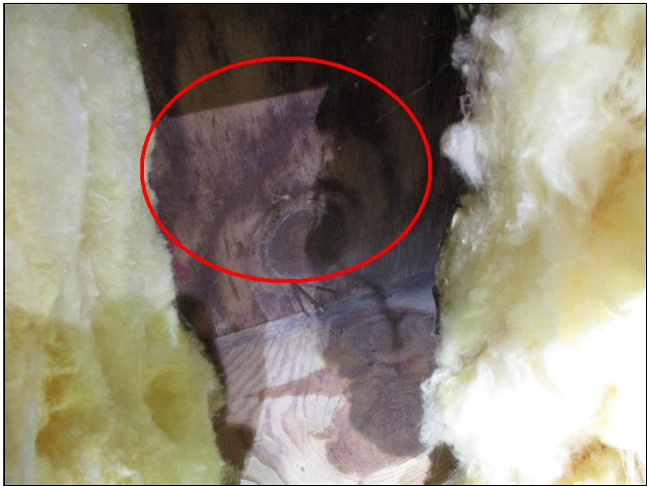
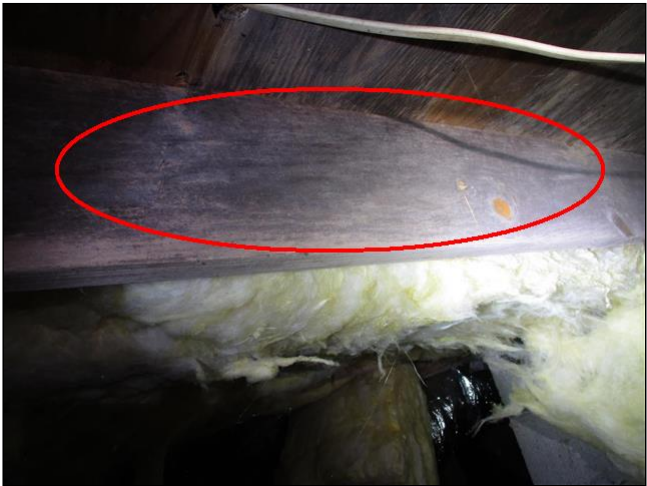
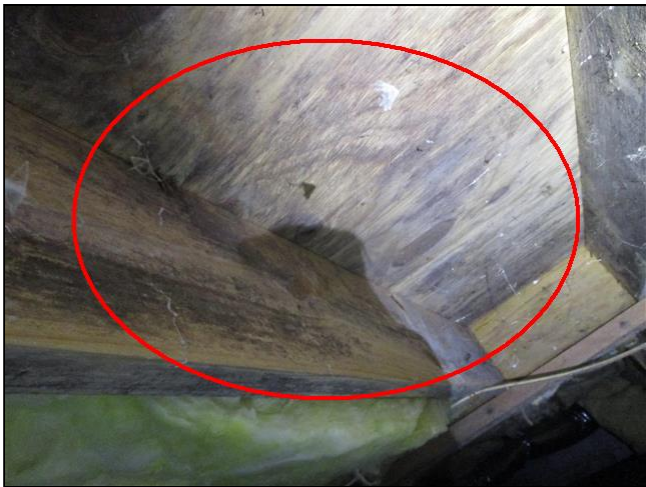
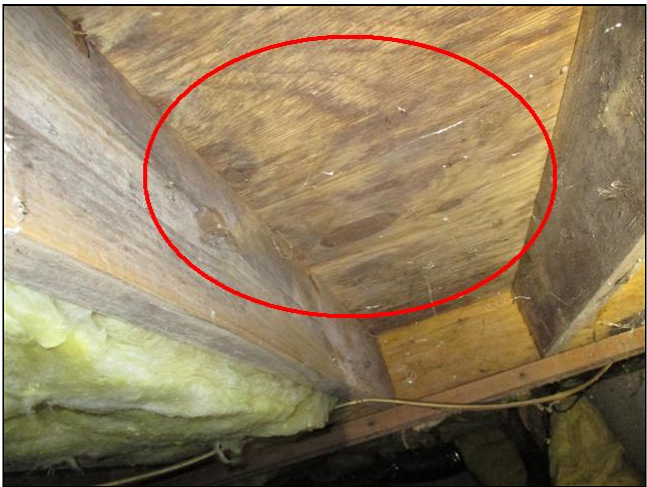
(2) We noted what appeared to be potential fungal growth present on the floor assembly in various areas at the crawl space. We recommend further evaluation by a qualified mold remediation contractor.

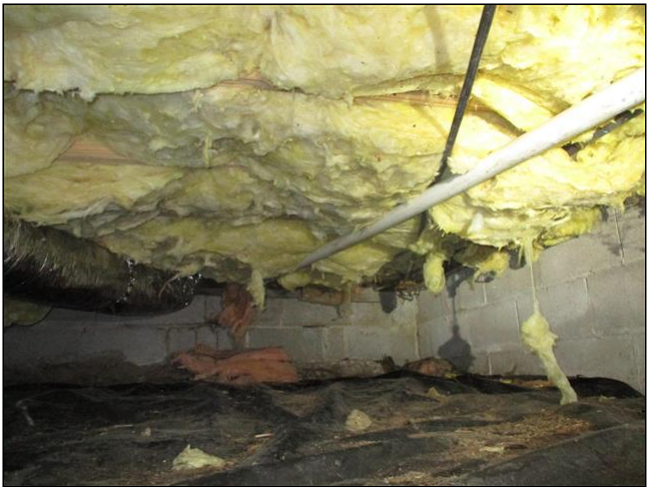
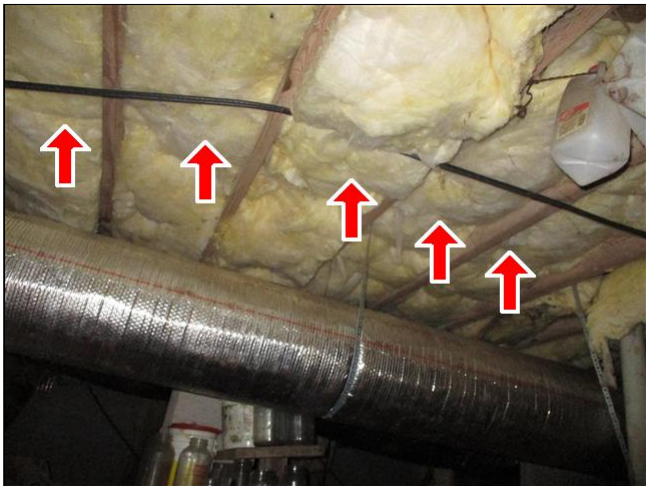
(3) Insulation was present between the floor joists at the crawl space. When the outside temperature is hot/humid and the HVAC system is operating in cooling mode(the duct work sweats in most crawl spaces), the moisture content tends to be higher at the crawl space. When the moisture content is higher at the crawl space, condensation tends to accumulate on the insulation between the floor joists, which then exposes the floor assembly to moisture. We recommend to remove the insulation from the crawl space to help prevent moisture exposure to the floor assembly. Most of the floor assembly and some of the plumbing were not visible for inspection at the crawl space due to the insulation blocking the view.

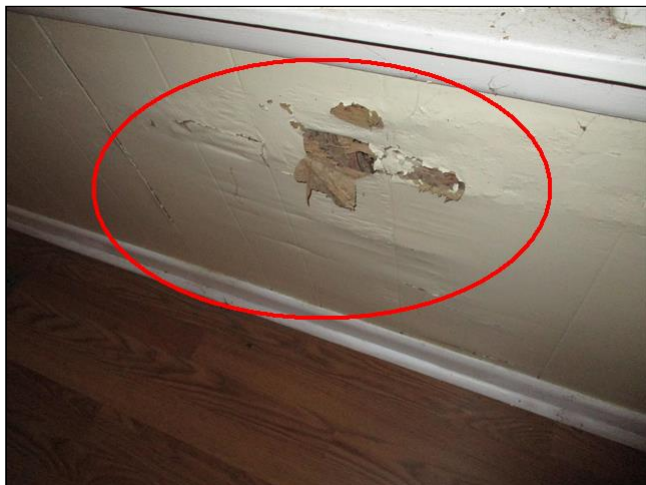
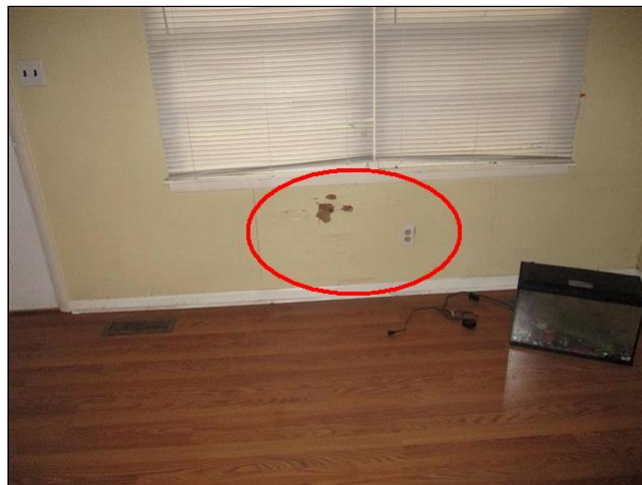
The wall assembly appeared to have termite damage below the window at the living room. Also, the floor assembly below this window appeared to have some termite damage at the crawl space. We recommend that a qualified contractor evaluate and make any needed repairs or replacements.

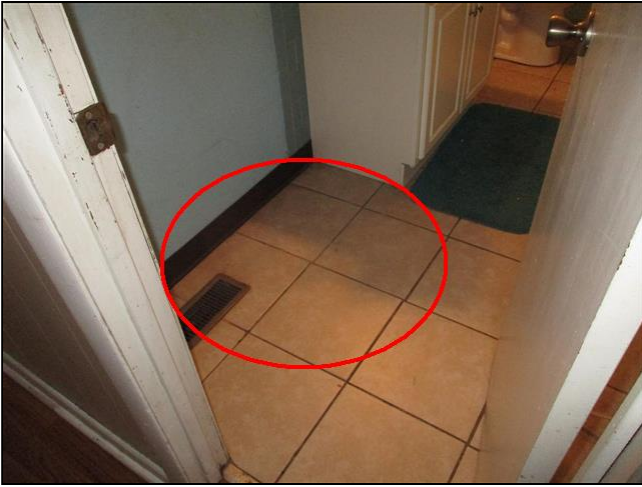
4.3 Item 1(Picture)

(1) The floor assembly appeared to have a dip at the bathroom. We recommend that a qualified contractor evaluate and make any needed repairs or replacements.

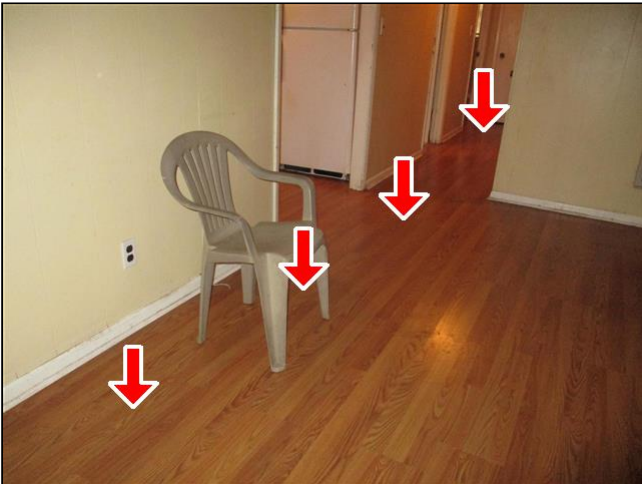
4.3 Item 2(Picture)

(2) The floor assembly appeared to have a dip/hump along the middle of the home. The dip/hump appeared to be near the girder beam. The floor joists could potentially have dropped down slightly away from the girder beam at the crawl space. We recommend that a qualified contractor evaluate and make any needed repairs or replacements.

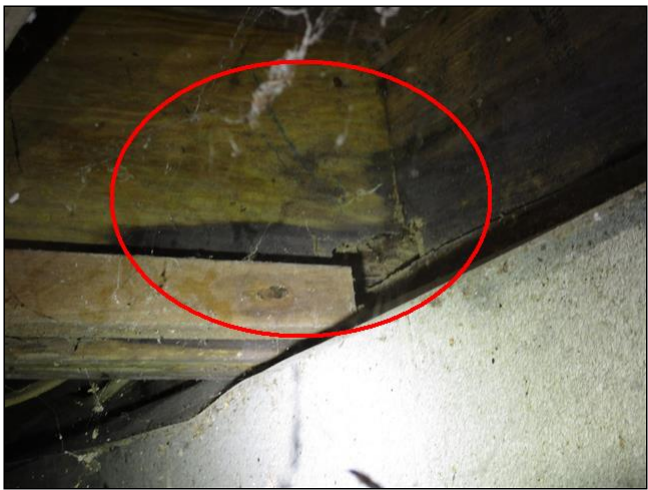
4.3 Item 5(Picture)

(4) The outer band joist and girder beam appeared to have some termite damage in one general area near the carport at the crawl space. We recommend that a qualified contractor evaluate and make any needed repairs or replacements.

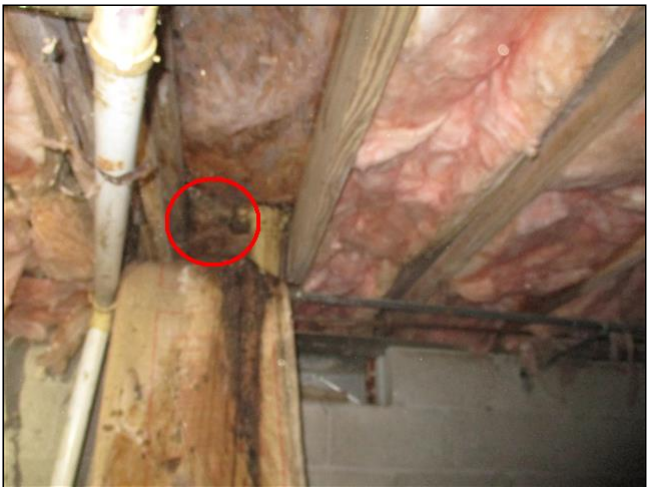
4.3 Item 9(Picture)

(6) The sub-flooring appeared to have some deterioration in two areas near the bathroom at the crawl space. We recommend that a qualified contractor evaluate and make any needed repairs or replacements.

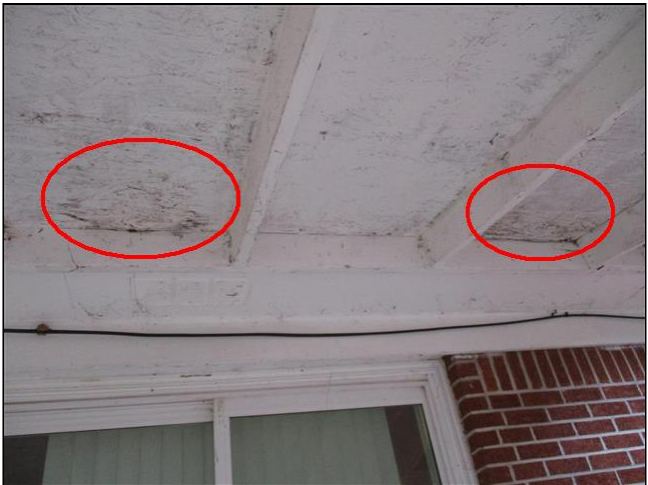
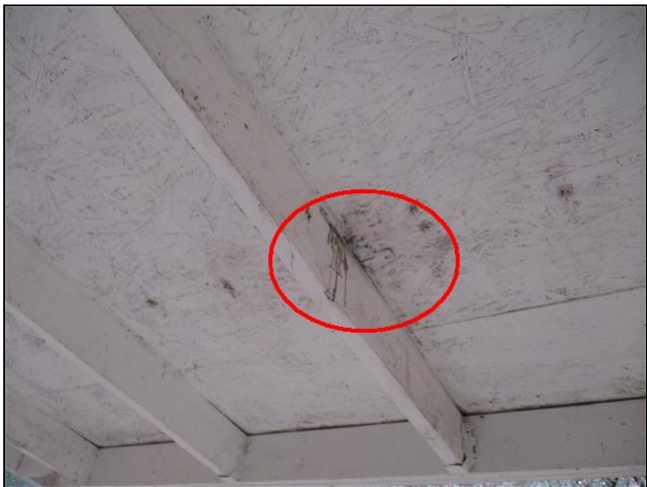
The plywood roof decking appeared to have some deterioration in areas overhead at the back porch.
Repair or replace as needed.

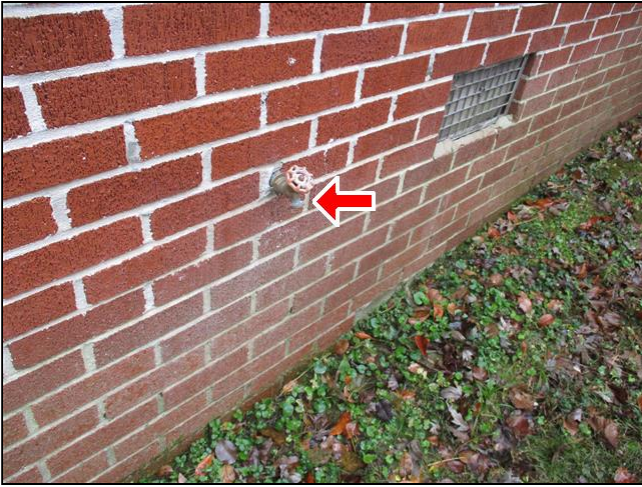
5.1 Item 1(Picture)

(1) With the water turned off, water was dripping from the exterior water spigot at the back of the home. Repair or replace as needed.

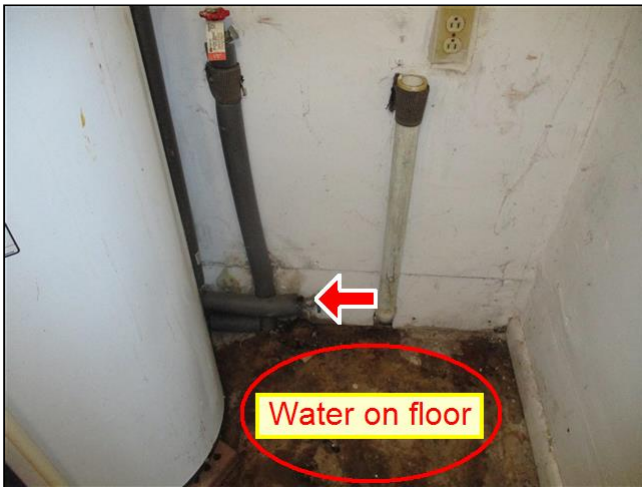
5.1 Item 2(Picture)

(2) With the water turned off, water was dripping from one washing machine hook-up valve at the laundry room. Repair or replace as needed.

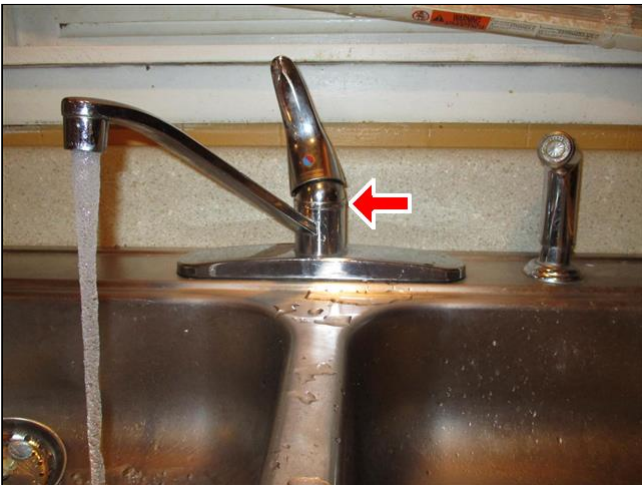
5.1 Item 3(Picture)

(3) The kitchen sink faucet appeared to leak when turning the faucet from side to side. Repair or replace as needed.

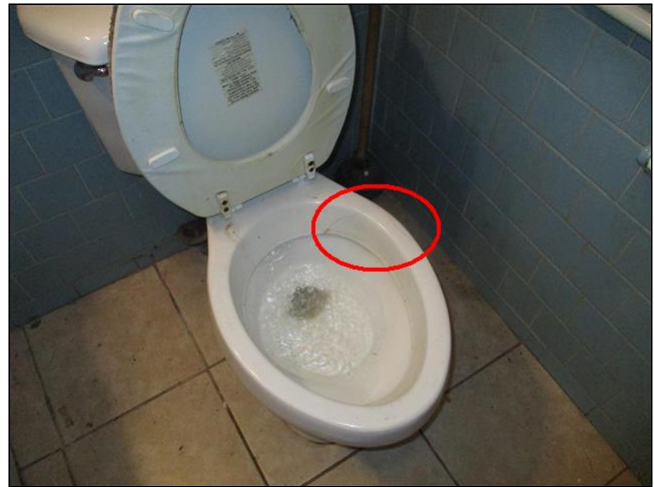
5.1 Item 6(Picture)

(5) The toilet bowl appeared to be cracked. Replace as needed.

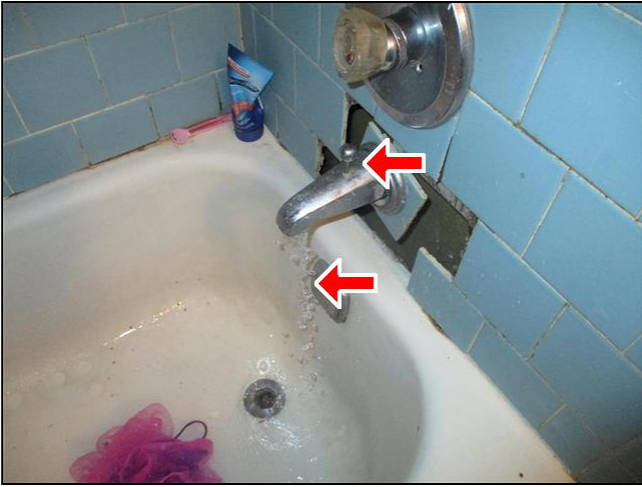
5.1 Item 8(Picture)

(7) The shower diverter appeared to not function properly at the bathroom. Some water was still flowing from the spout with the diverter engaged. Repair or replace as needed.

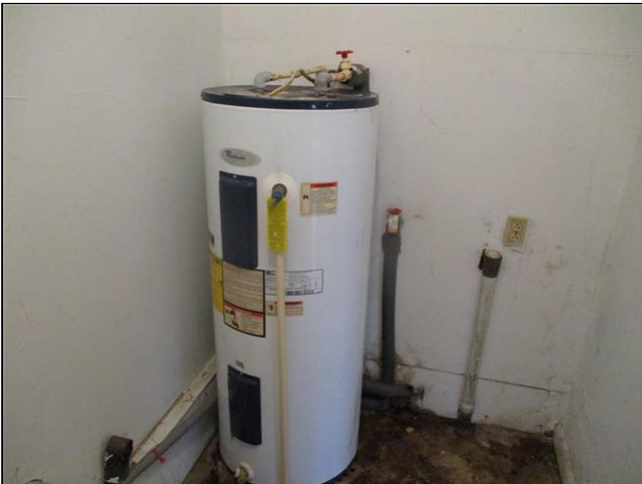
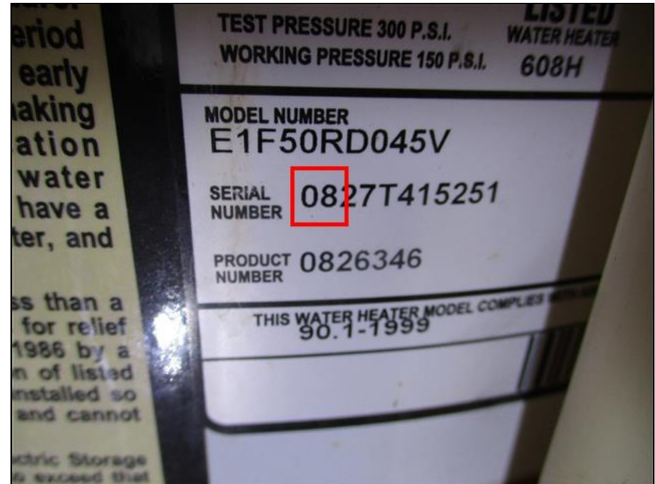
The water heater appeared to be a 2008 model. The average life expectancy for a water heater is roughly 8-12 years. Our interpretation of the manufacture date could potentially be wrong.

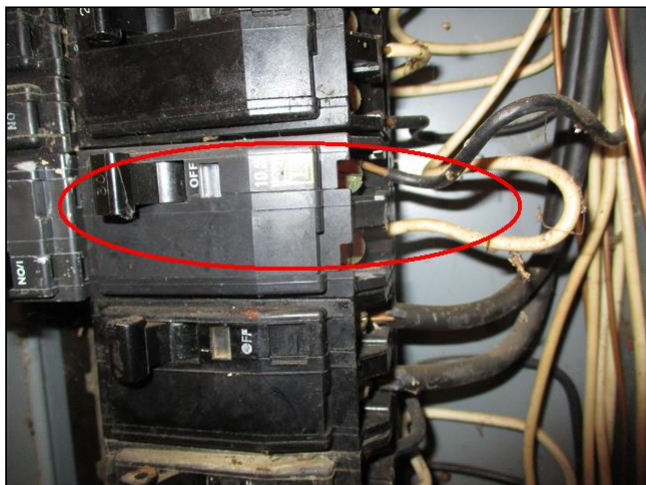
6.2 Item 1(Picture)

The branch circuit wiring may not be compatible with one circuit breaker inside the electric service panel. It appeared that a 30amp circuit breaker was used with 12gauge wiring on one circuit. The circuit breaker may be oversized for the gauge of wiring. We recommend further evaluation by a qualified electrical contractor.

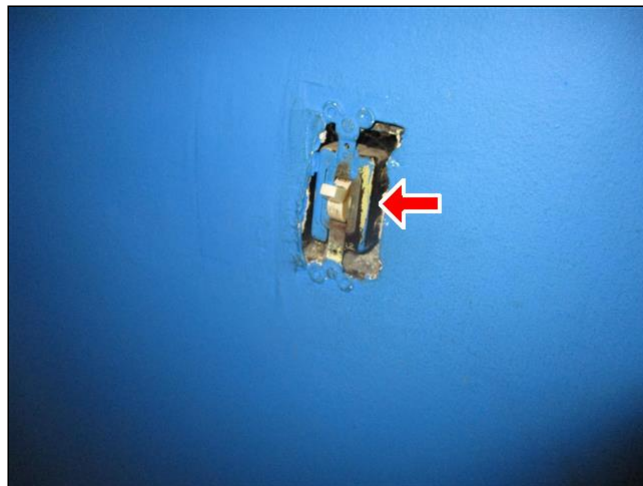
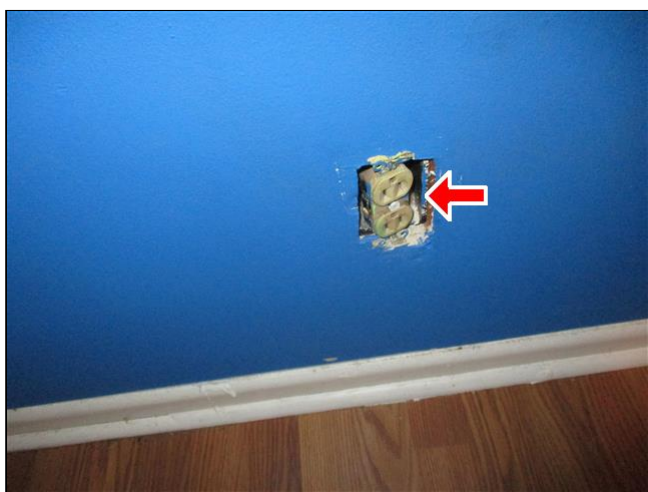
(2) A few of the outlet covers were missing in the home. Replace for safety enhancement.

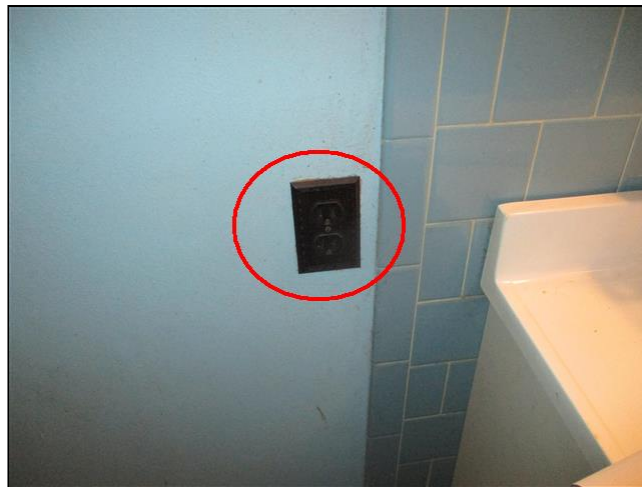
6.5 Item 2(Picture)

The receptacles appeared to have no GFCI protection at the laundry room, kitchen countertops and bathroom. We recommend that these receptacles have GFCI protection for safety enhancement. It is generally recommended that readily accessible receptacles within 6ft of wet areas have GFCI protection except for when dedicated non-GFCI protected circuits are needed. A GFCI outlet is an electrical outlet which is designed to protect people from deadly electric shock.

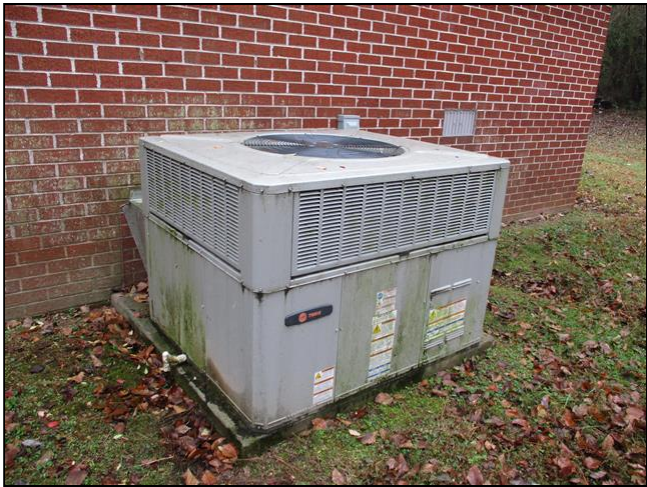
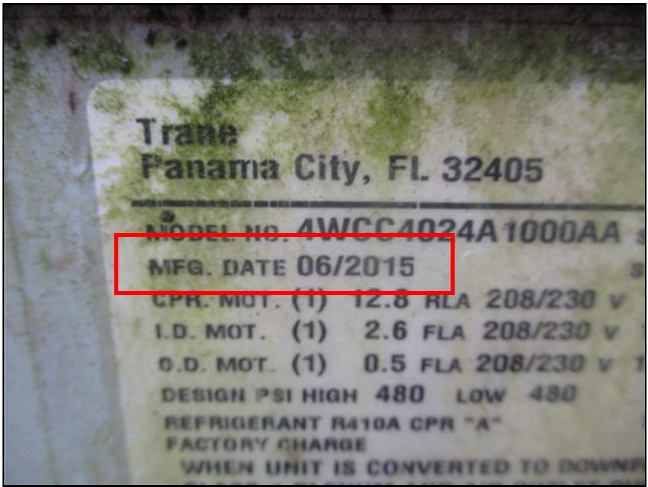
The HVAC unit appeared to be a 2015 model. The average life expectancy for an HVAC unit is roughly 12-15 years.

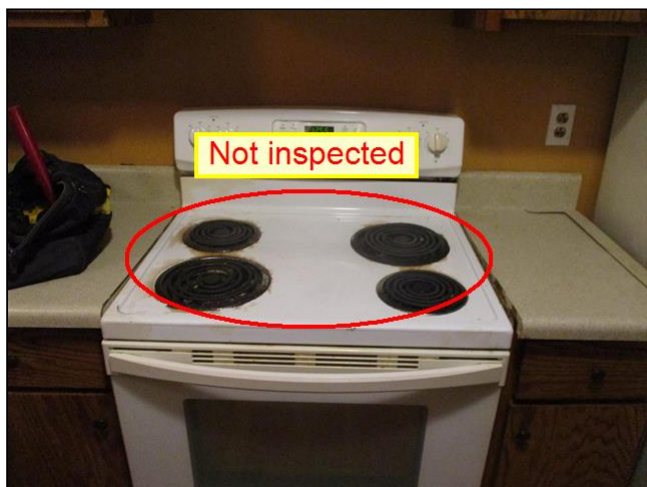
9.0 Item 1(Picture)

We tested the stove in bake and broil mode. We did not test the stove top eyes. There was too much debris present around the eyes and they were smoking heavily as soon as we turned them on.

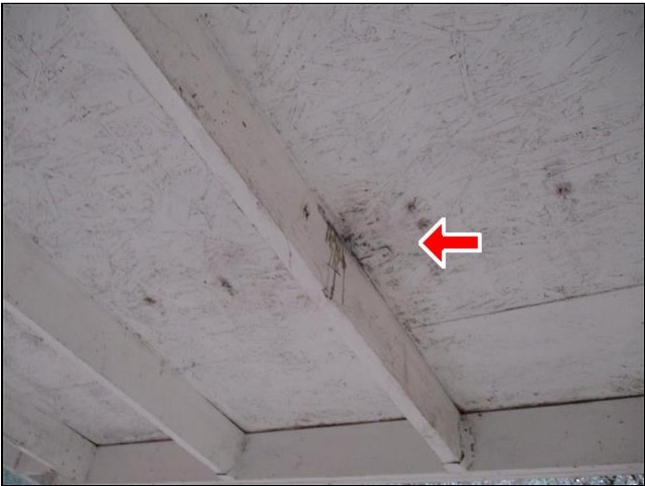
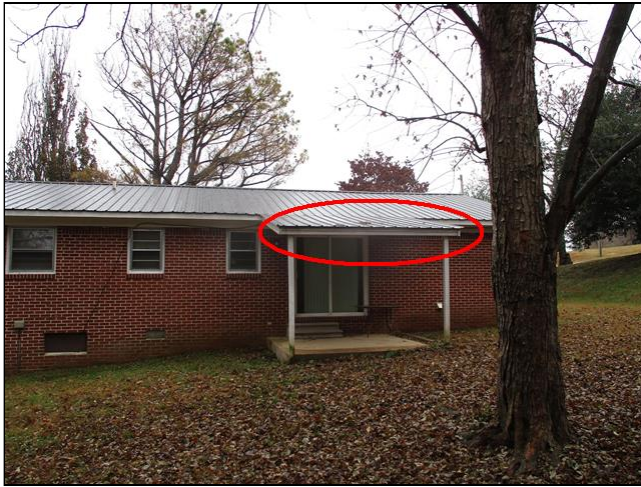
The plywood roof decking had some deterioration in areas at the back porch. The deterioration could potentially be the result of an active or past leak. Repair or replace as needed.

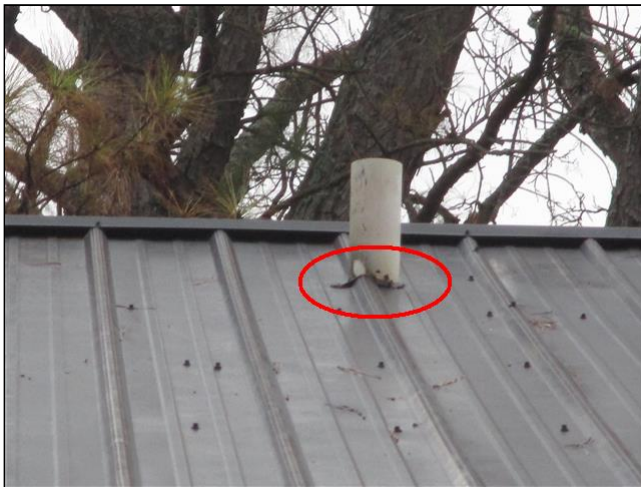
1.1 Item 1(Picture)

(1) It appeared that caulking/sealant was used for flashing around the base of the plumbing vent at the roof. Caulking/sealant can crack/separate potentially leaving an open gap for water intrusion. We recommend that a proper boot flashing be installed to help prevent water intrusion.

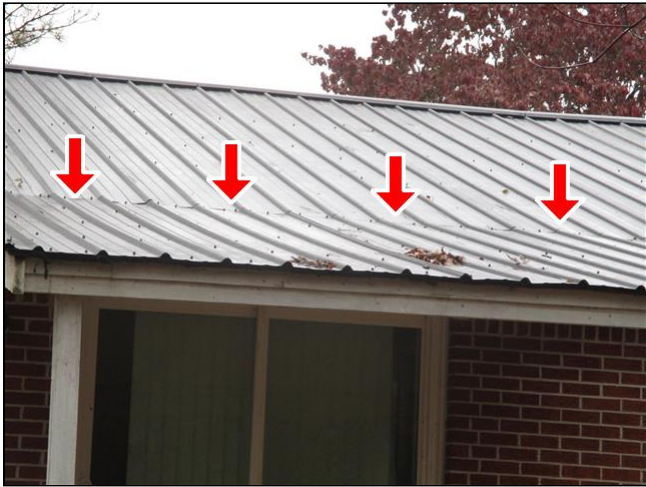
1.1 Item 5(Picture)

(3) It appeared that transition flashing was not installed where the roof pitch changes at the back of the home. Transition flashing helps prevent water intrusion. We recommend that a qualified roofing contractor evaluate and make any needed repairs or replacements.

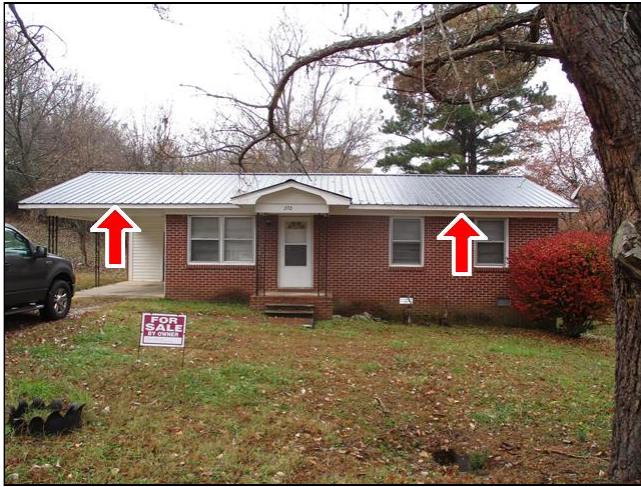
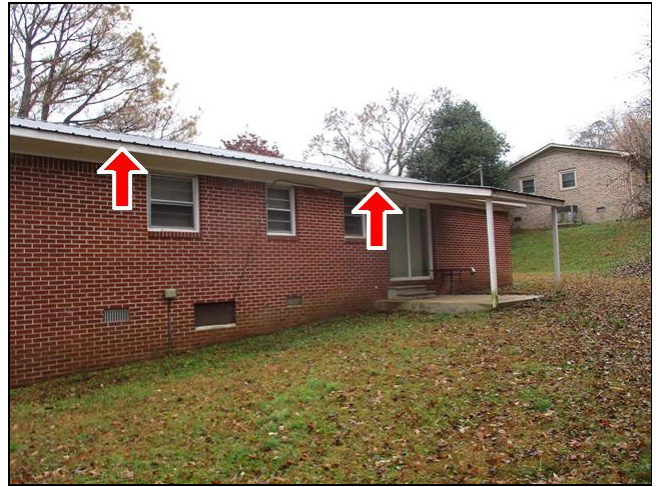
It appeared that gutters and downspouts were not present on the home. We recommend to install gutters and downspouts to help divert water away from the foundation.
