Inspection Report

Property Address:
307 Hidden Drive
Winchester TN 37398

Belmar Home Inspections

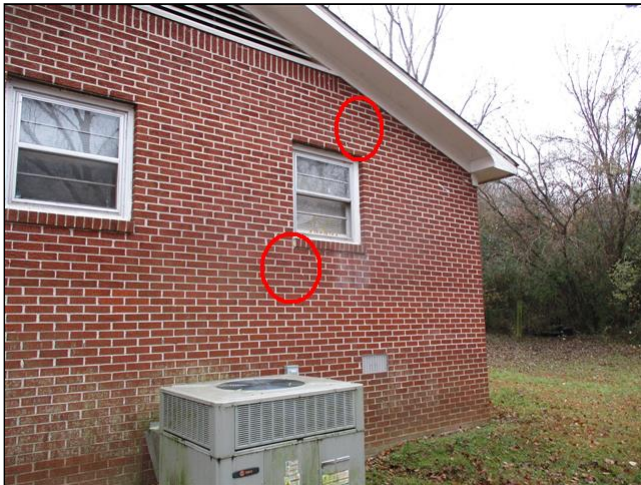
2.0 Item 1(Picture)

The exterior brick wall cladding revealed cracks indicating movement at the gable end on the right side of the home. We recommend that a qualified contractor evaluate and make any needed repairs or replacements. We noted these cracks in the foundation section of the report also.

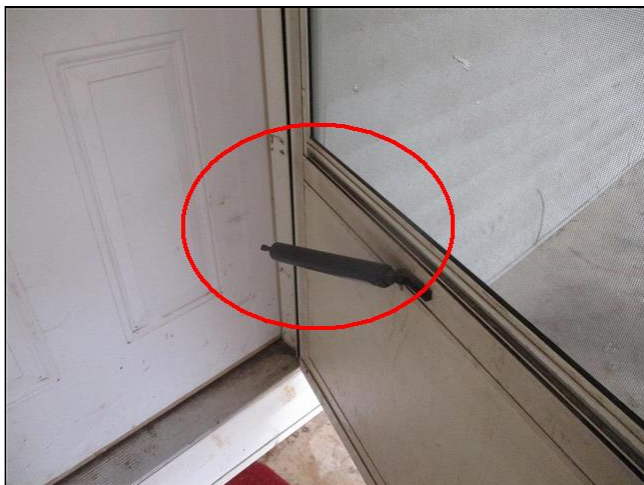
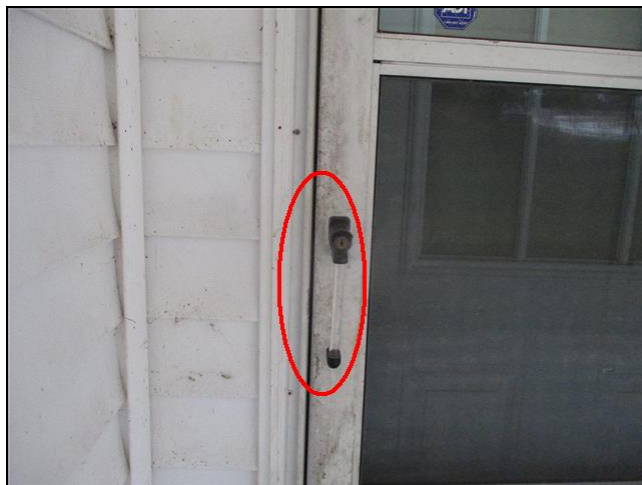
(1) The pneumatic door closer on the storm door appeared to be detached at the carport. Also, this door would not latch and the handle appeared to be damaged. Repair or replace as needed.

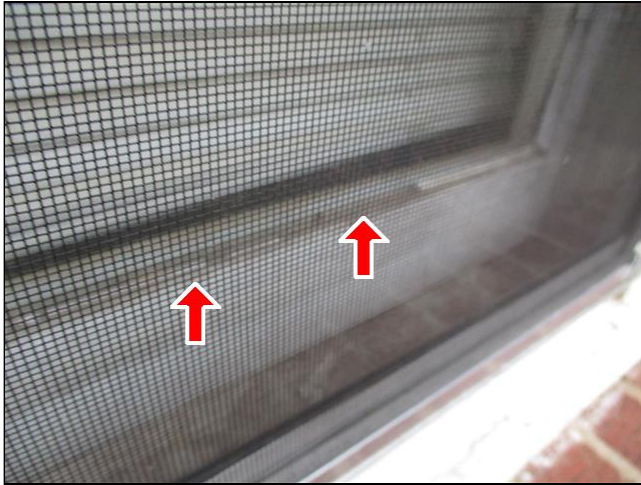
2.2 Item 2(Picture)

(2) The exterior window glazing compound appeared to be deteriorated/loose/missing on some windows. Repair or replace as needed.

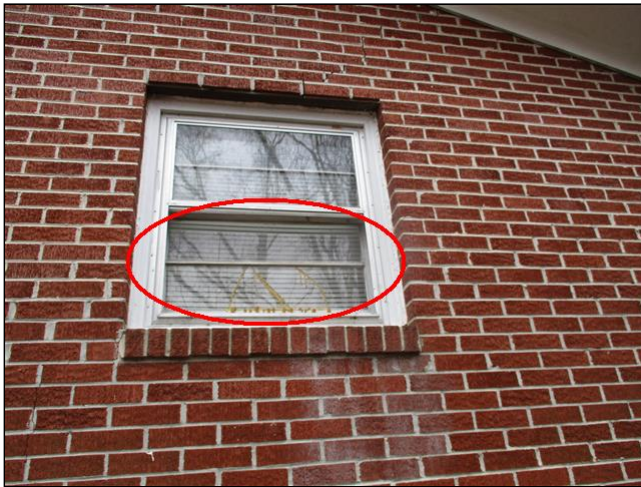
2.2 Item 4(Picture)

(3) One storm window pane appeared to be missing at the gable end on the right side of the home. Replace as needed.

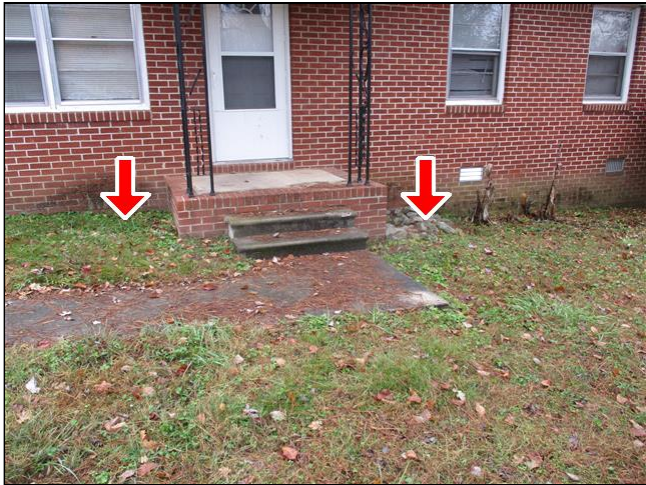
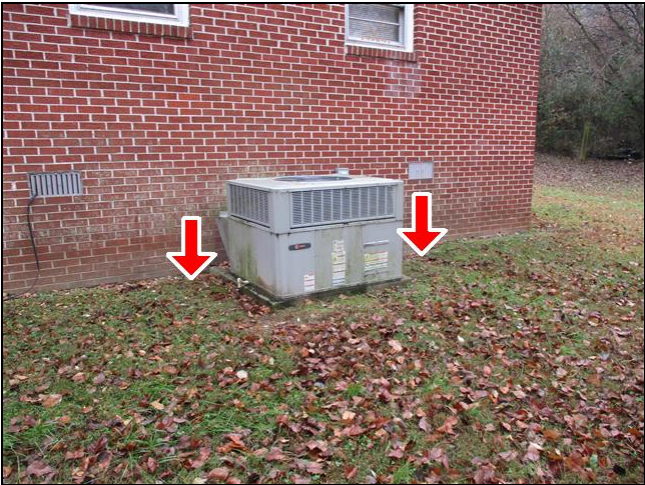
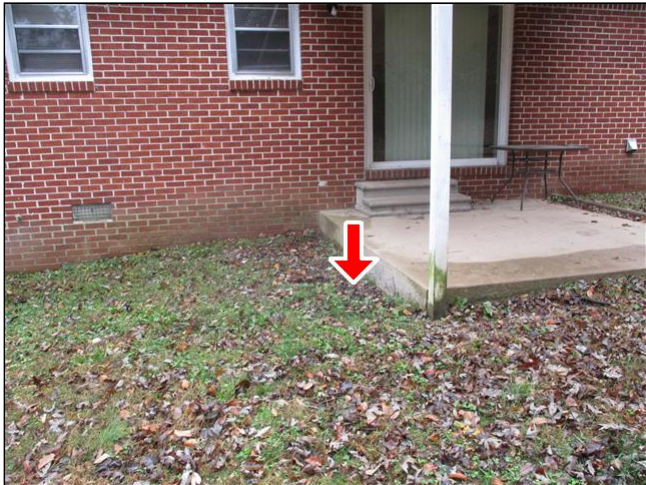
The yard appeared to be low in areas near the home. It is recommended that the yard have a positive slope away from the home in all areas if possible to help divert water away from the foundation. Repair as needed.

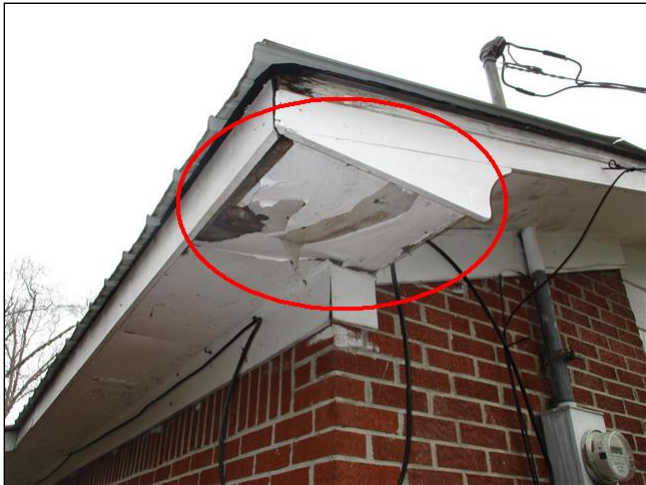
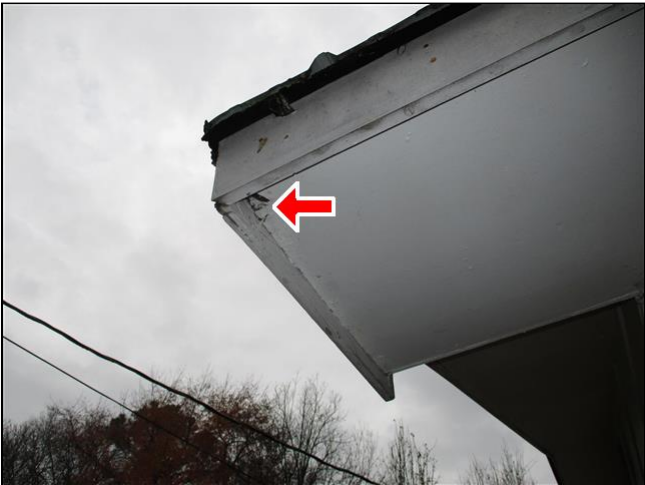
We noted what appeared to be deterioration/water damage along the eaves in a few areas around the home. Repair or replace as needed.

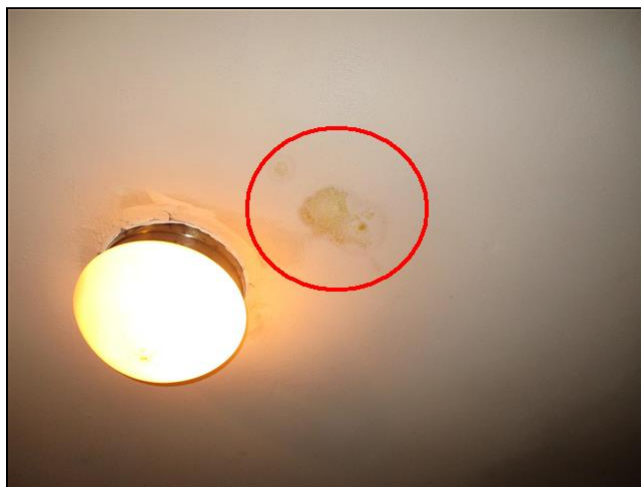
3.0 Item 2(Picture)

The ceiling revealed a stain at the kitchen and bathroom. The stains could potentially be the result of an active or past leak. We recommend further evaluation by a qualified contractor.

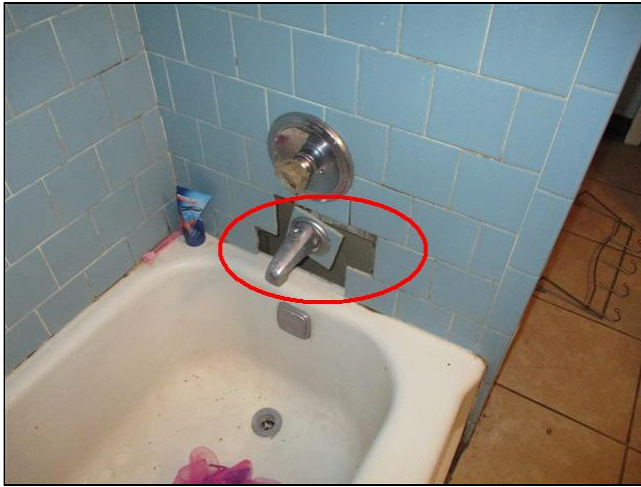
3.1 Item 1(Picture)

The wall tiles appeared to be damaged/missing in one general area inside the shower. Repair or replace as needed.

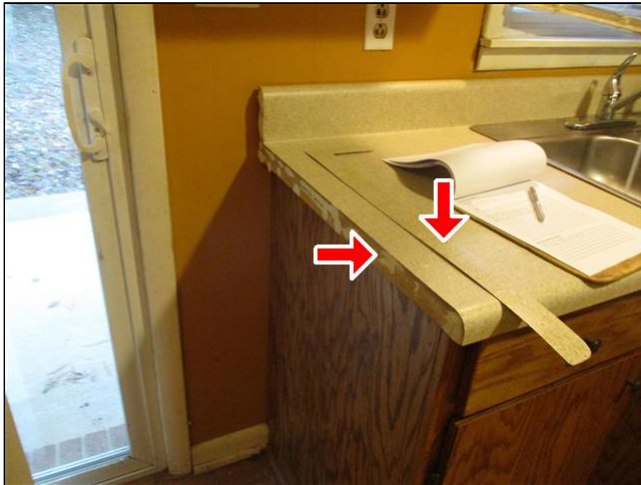
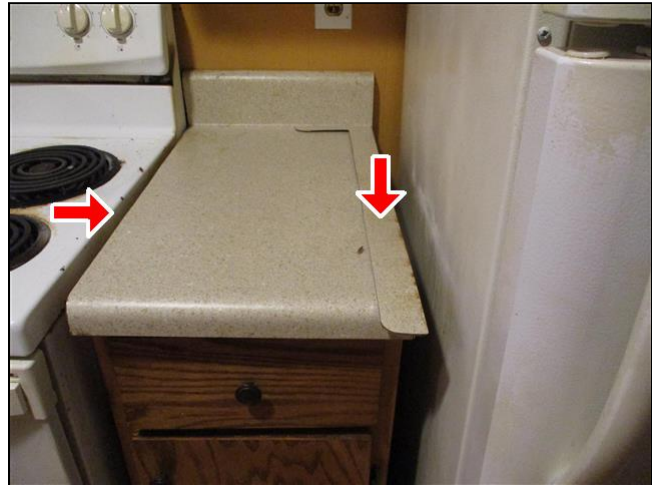
The laminate end caps for the countertops appeared to be detached at the kitchen. Repair or replace as needed.

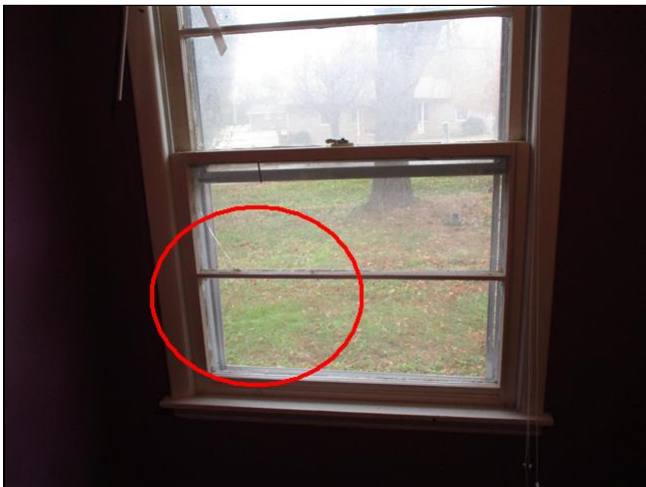
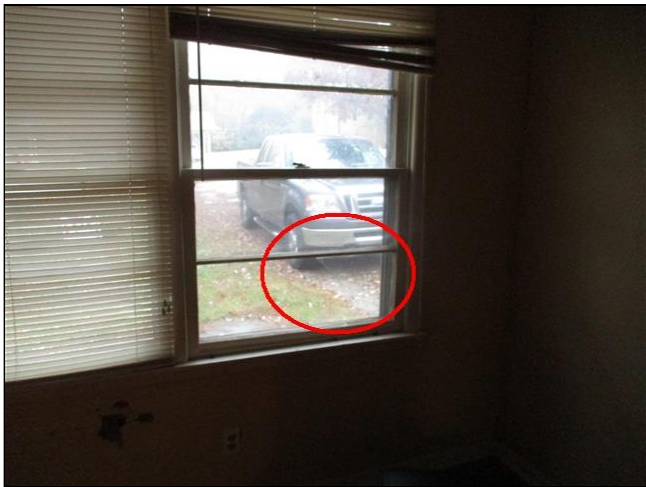
(3) The glass pane appeared to be damaged on one window at the back corner bedroom, the window at the front middle bedroom and one window at the living room. Repair or replace as needed.

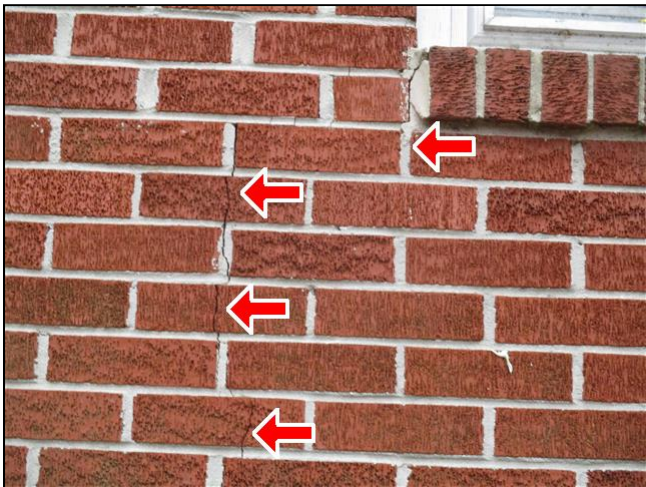
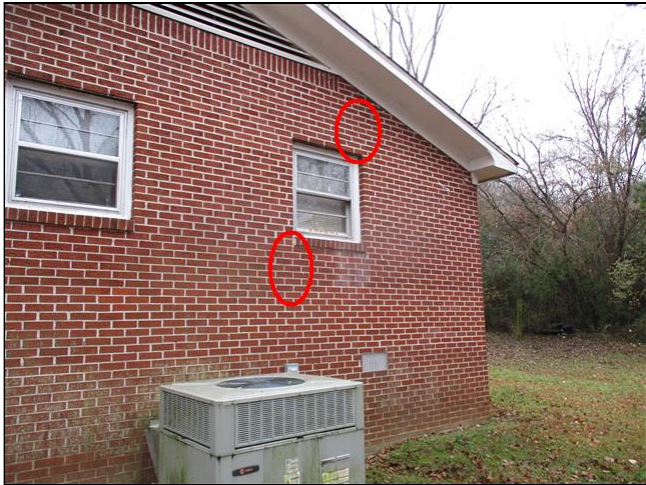
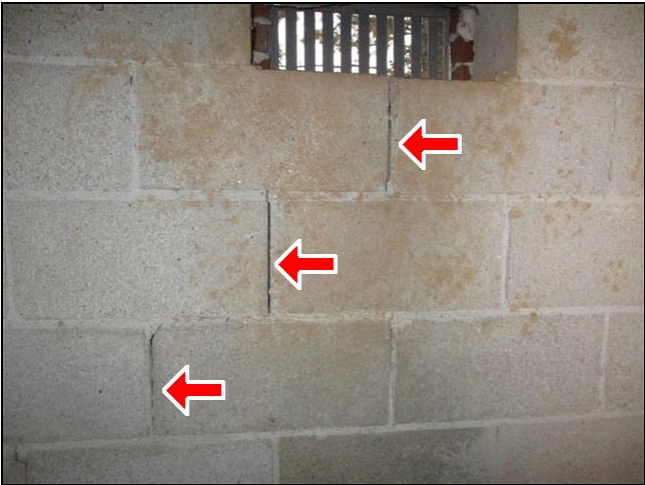
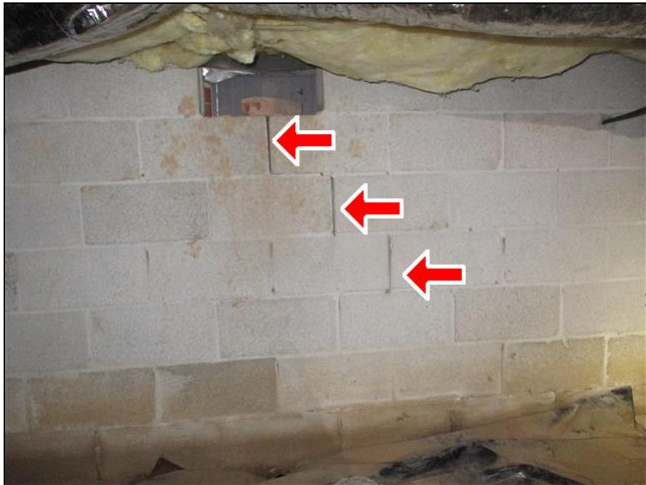
(1) The exterior brick wall cladding revealed cracks indicating movement near one window at the gable on the right side of the home. Also, the masonry block foundation wall revealed cracks along the mortar joints indicating movement on this same end of the home at the crawl space. We recommend that a qualified contractor evaluate and make any needed repairs or replacements.

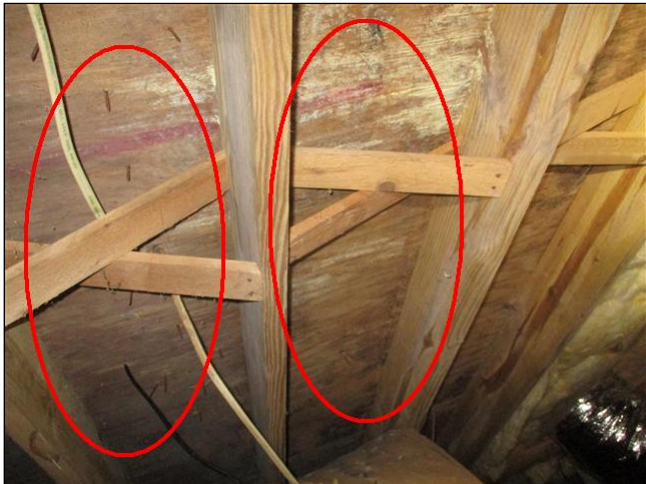
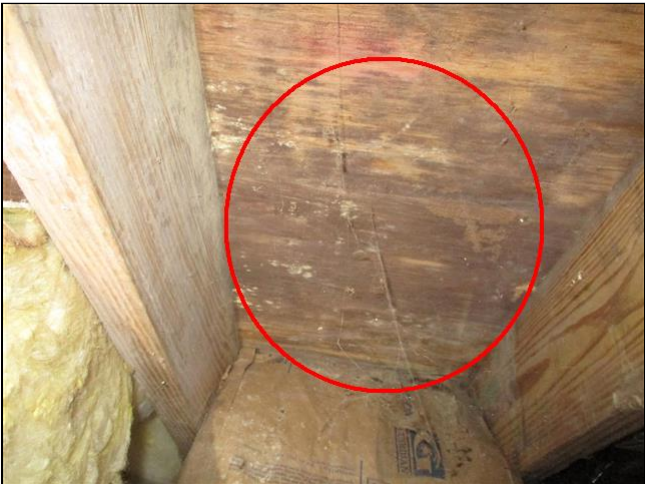
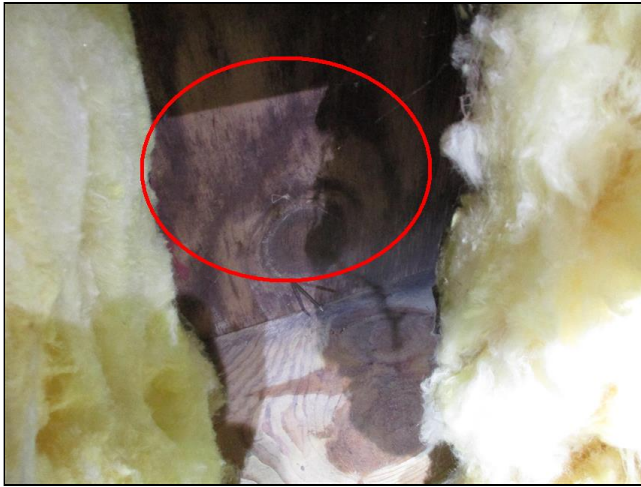
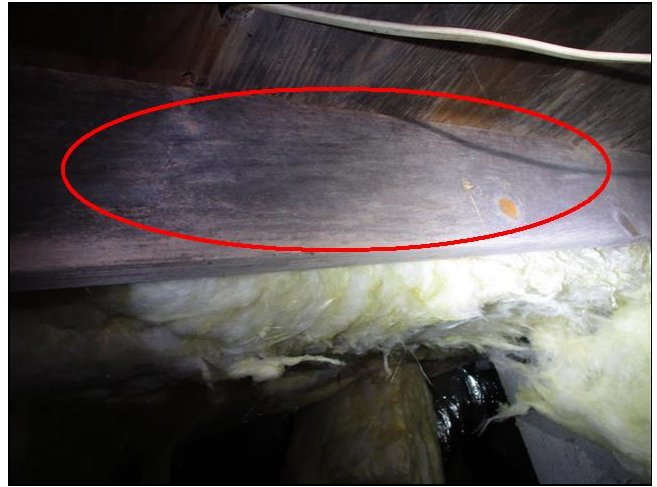
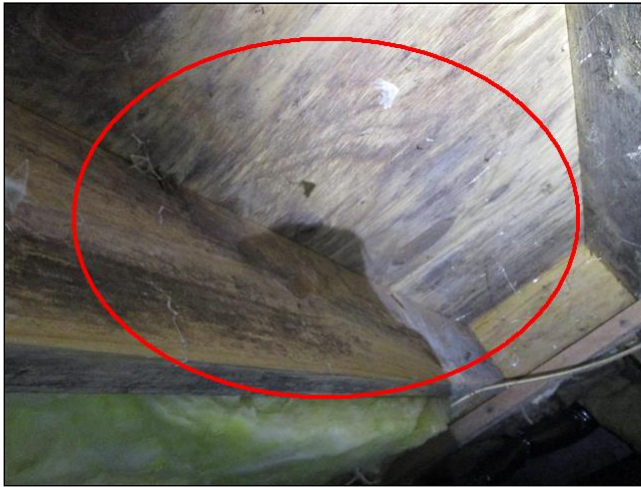
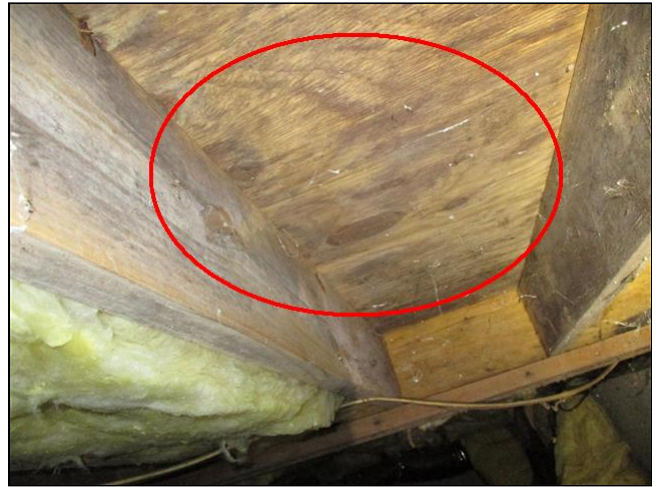
(2) We noted what appeared to be potential fungal growth present on the floor assembly in various areas at the crawl space. We recommend further evaluation by a qualified mold remediation contractor.

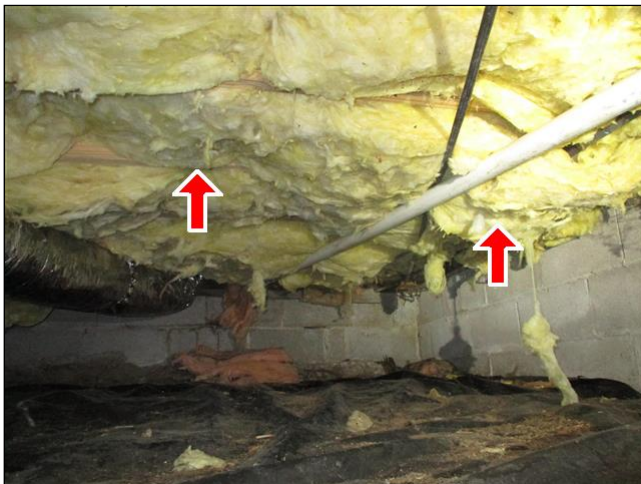
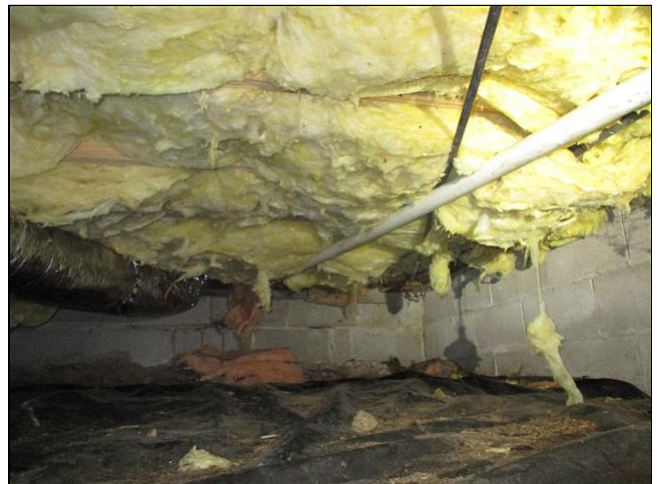
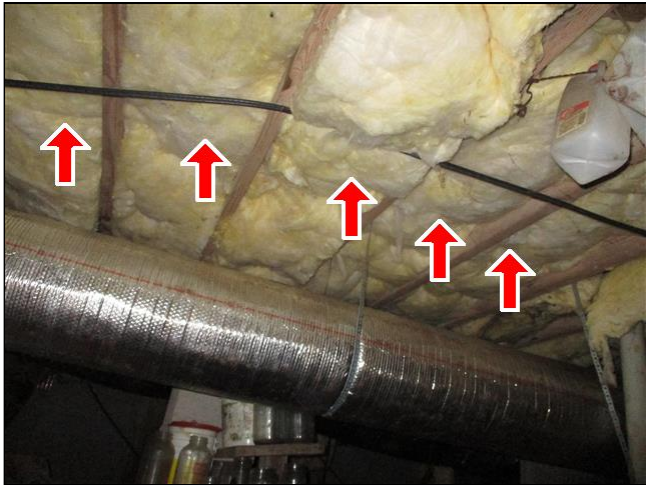
(3) Insulation was present between the floor joists at the crawl space. When the outside temperature is hot/humid and the HVAC system is operating in cooling mode(the duct work sweats in most crawl spaces), the moisture content tends to be higher at the crawl space. When the moisture content is higher at the crawl space, condensation tends to accumulate on the insulation between the floor joists, which then exposes the floor assembly to moisture. We recommend to remove the insulation from the crawl space to help prevent moisture exposure to the floor assembly. Most of the floor assembly and some of the plumbing were not visible for inspection at the crawl space due to the insulation blocking the view.

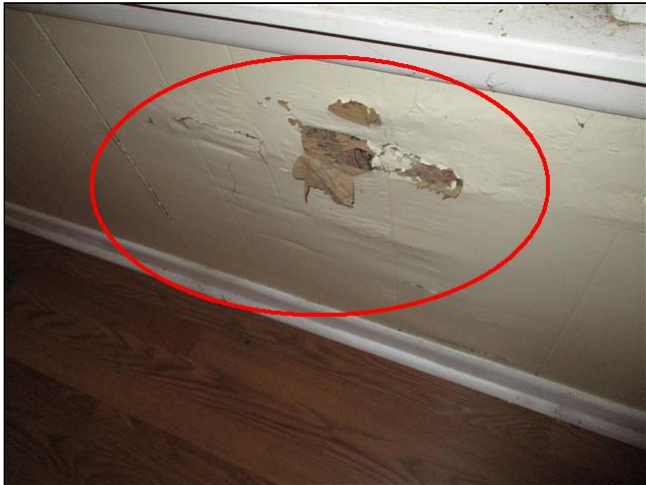
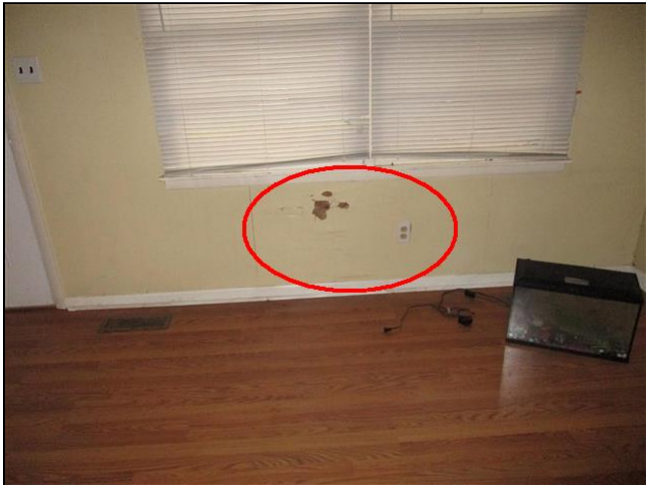
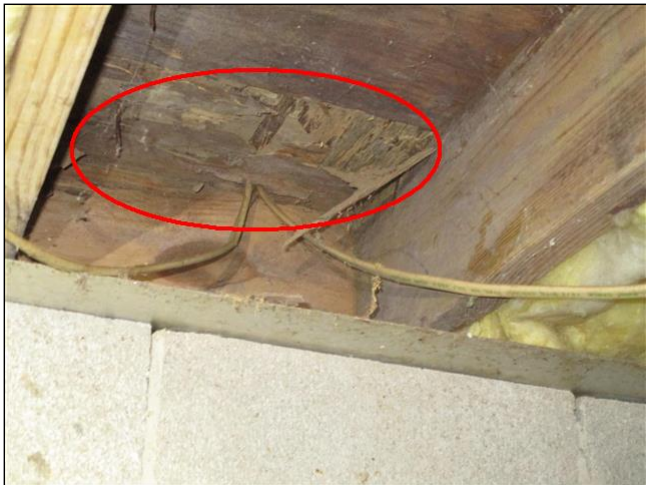
The wall assembly appeared to have termite damage below the window at the living room. Also, the floor assembly below this window appeared to have some termite damage at the crawl space. We recommend that a qualified contractor evaluate and make any needed repairs or replacements.

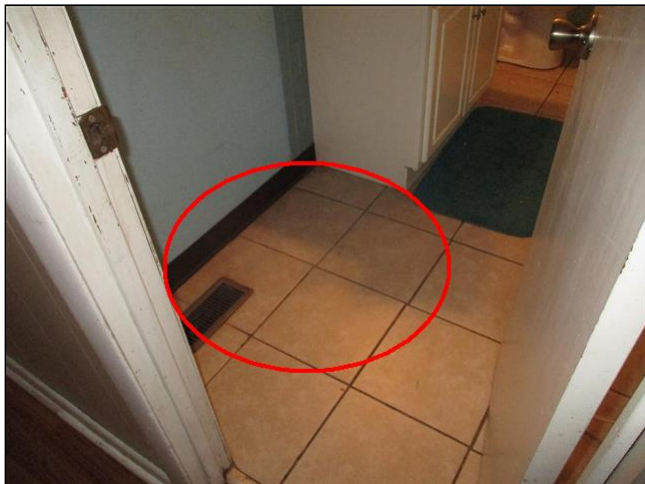
4.3 Item 1(Picture)

(1) The floor assembly appeared to have a dip at the bathroom. We recommend that a qualified contractor evaluate and make any needed repairs or replacements.

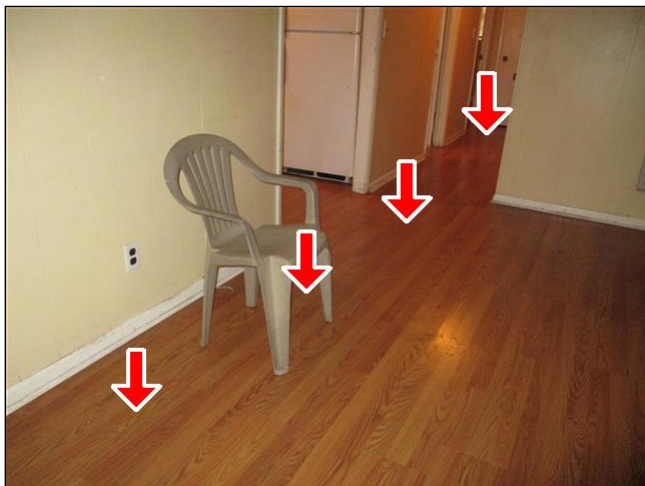
4.3 Item 2(Picture)

(2) The floor assembly appeared to have a dip/hump along the middle of the home. The dip/hump appeared to be near the girder beam. The floor joists could potentially have dropped down slightly away from the girder beam at the crawl space. We recommend that a qualified contractor evaluate and make any needed repairs or replacements.

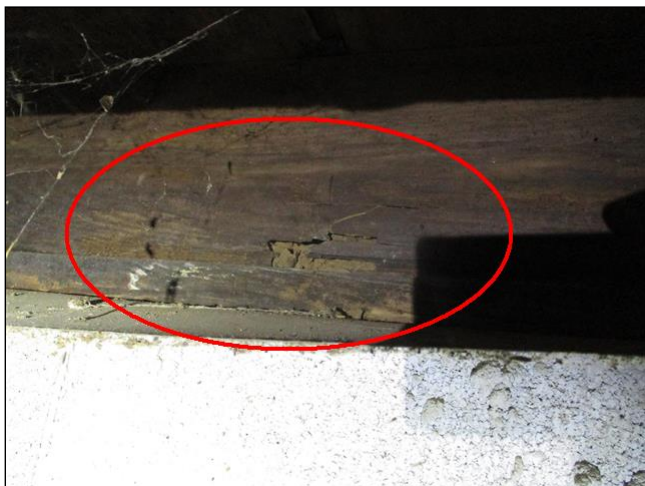
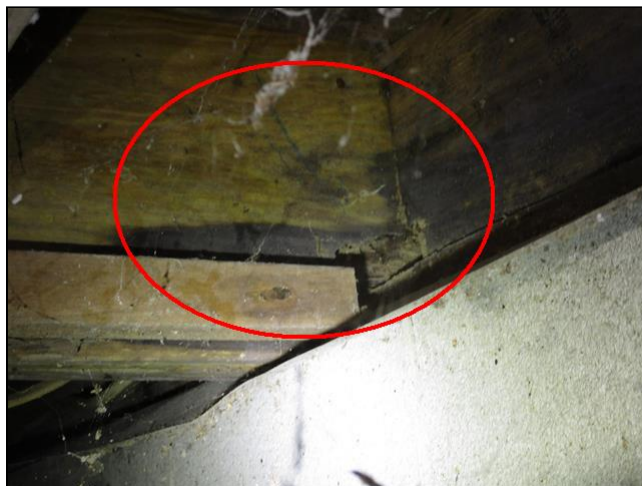
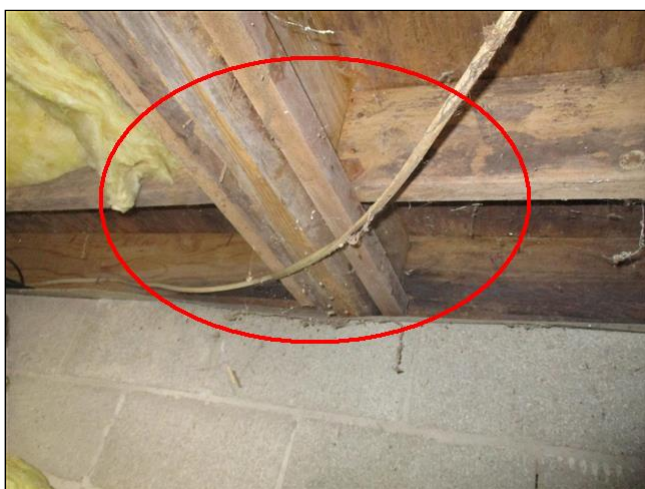
(4) The outer band joist and girder beam appeared to have some termite damage in one general area near the carport at the crawl space. We recommend that a qualified contractor evaluate and make any needed repairs or replacements.

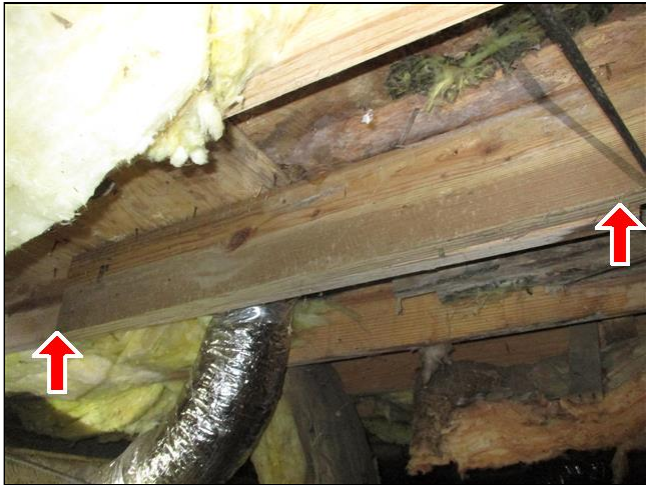
4.3 Item 7(Picture)

(5) One floor joist was spliced together and appeared to need bracing near the bathroom at the crawl space. Repair as needed.

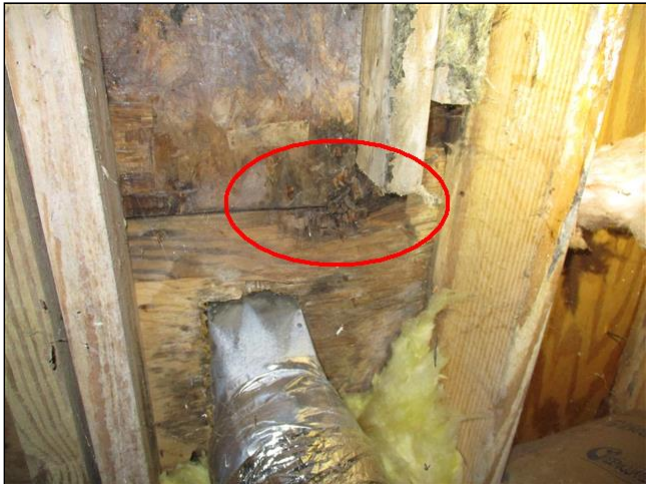
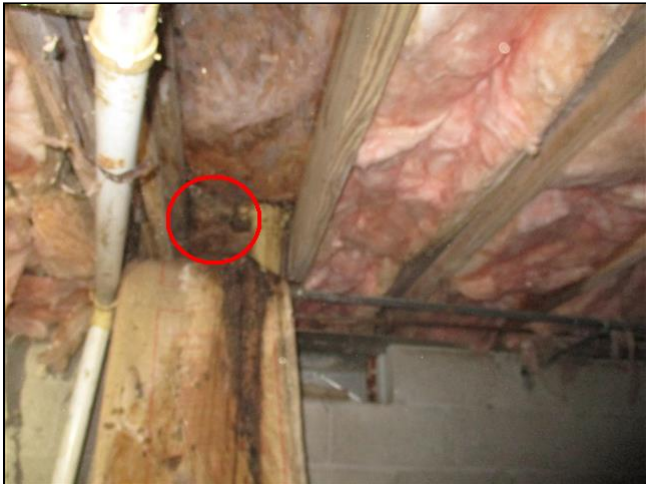
(6) The sub-flooring appeared to have some deterioration in two areas near the bathroom at the crawl space. We recommend that a qualified contractor evaluate and make any needed repairs or replacements.

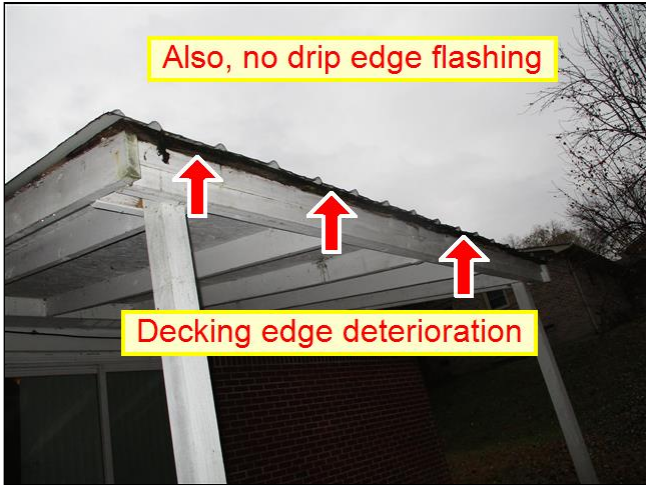
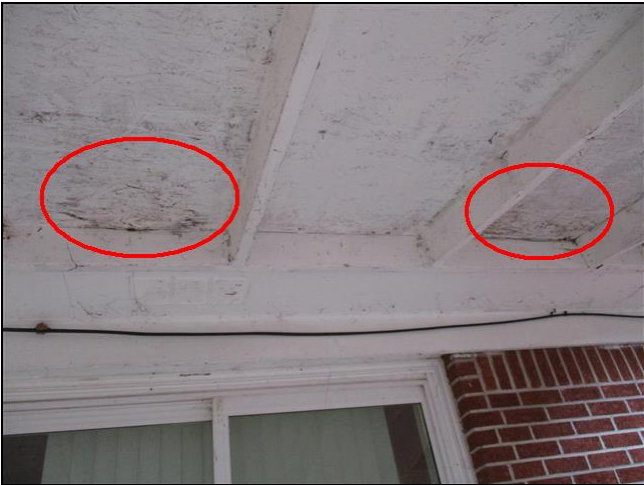
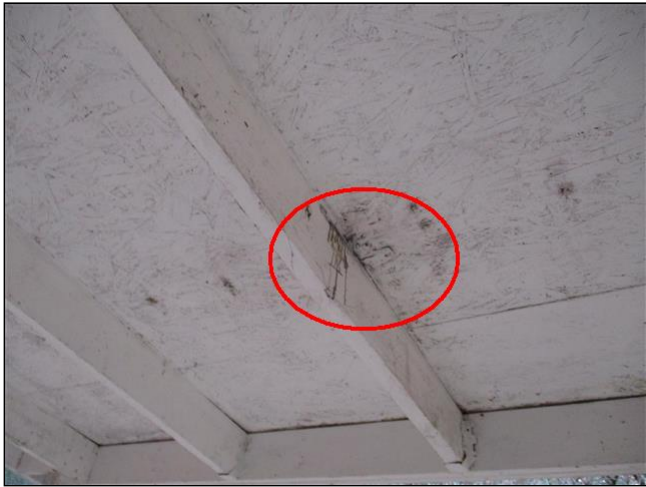
The plywood roof decking appeared to have some deterioration in areas overhead at the back porch. Repair or replace as needed.

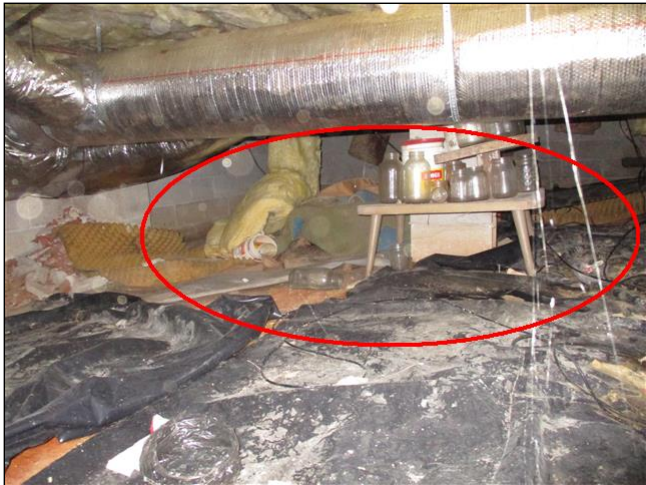
4.6 Item 1(Picture)

We recommend to remove any unneeded items/debris from the crawl space.

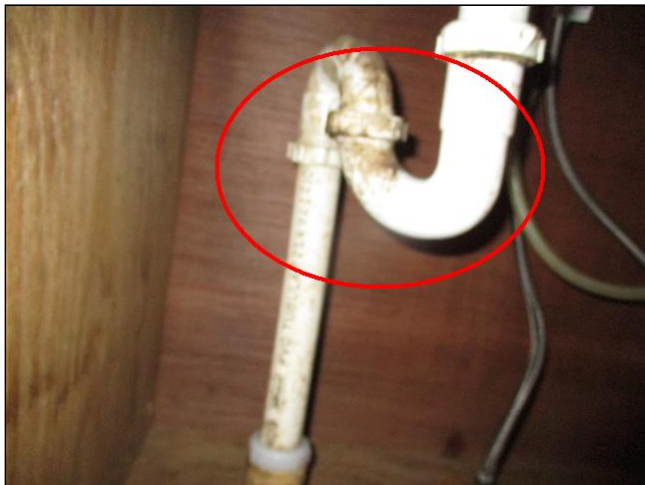
5.0 Item 1(Picture)

(1) It appeared that an s-trap was used on the drain line plumbing below the sink at the kitchen and bathroom. With an s-trap drain, the trap could potentially be siphoned dry with each use, which could allow sewer gases to enter the home. S-traps are common in older homes, but P-traps are used in most modern homes. If an s-trap gets siphoned dry, the trap can easily be filled by running more water down the drain. We recommend that a qualified plumbing contractor evaluate and make any needed repairs or replacements. S-traps are not considered a large concern.

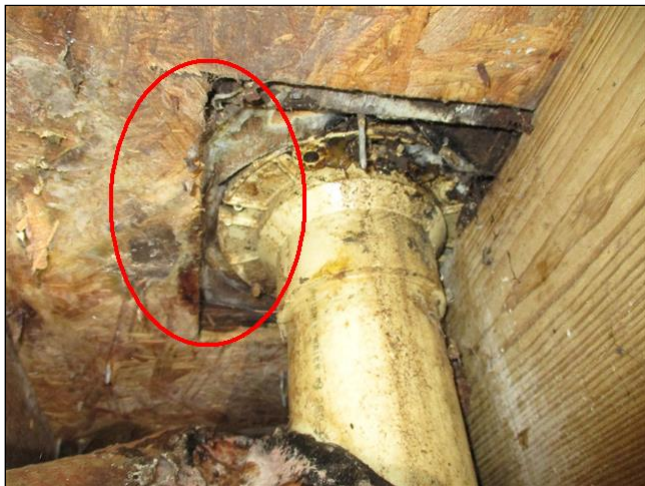
5.0 Item 2(Picture)

(2) It appeared that the toilet may have a bad seal. Water was dripping below the toilet at the crawl space. Repair or replace as needed.

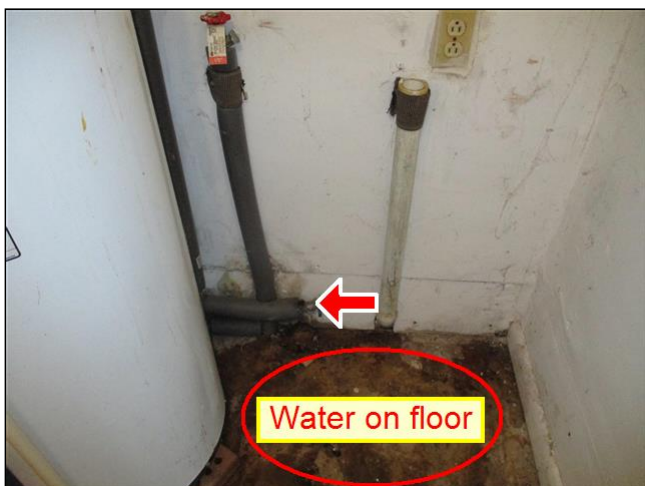
5.1 Item 2(Picture)

(2) With the water turned off, water was dripping from one washing machine hook-up valve at the laundry room. Repair or replace as needed.

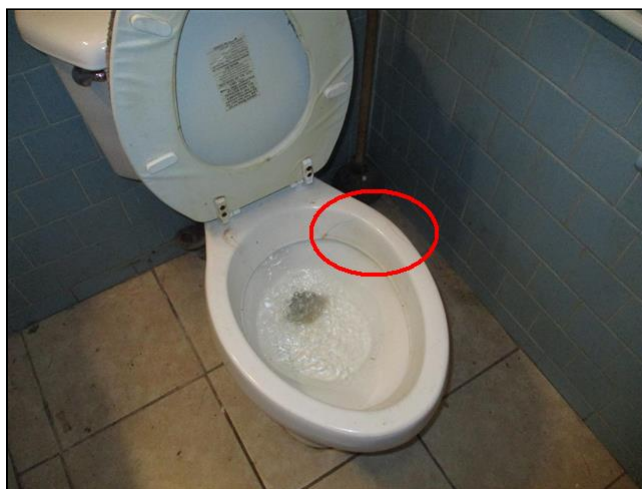
5.1 Item 6(Picture)

(5) The toilet bowl appeared to be cracked. Replace as needed.

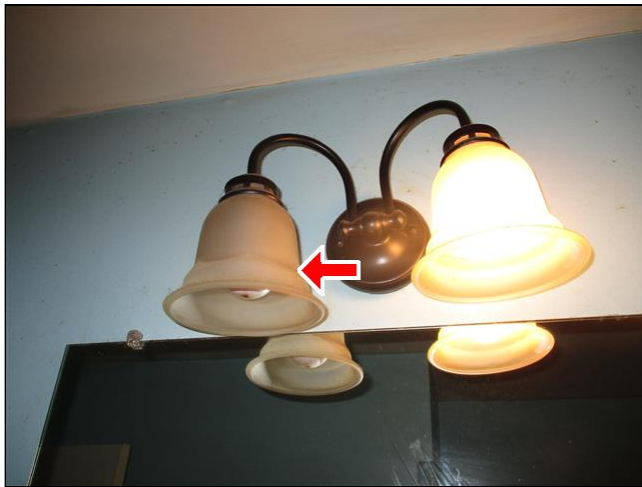
6.3 Item 1(Picture)

(1) One bulb appeared to be out or the light fixture may not function properly at the bathroom. We recommend to replace the bulb, then re-inspect the light fixture.

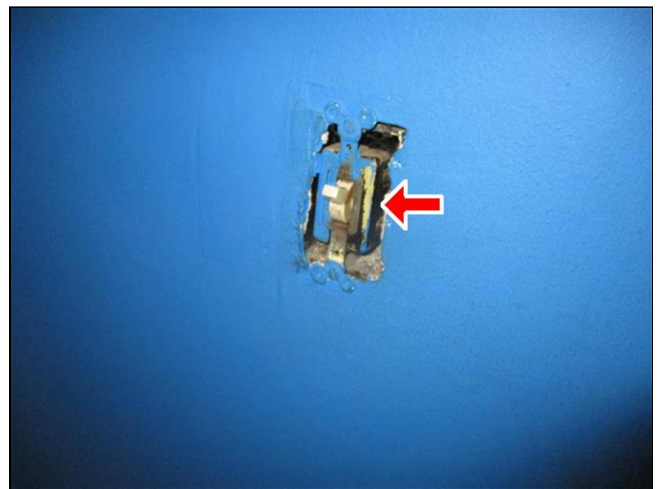
6.3 Item 3(Picture)

(2) A few of the outlet covers were missing in the home. Replace for safety enhancement.

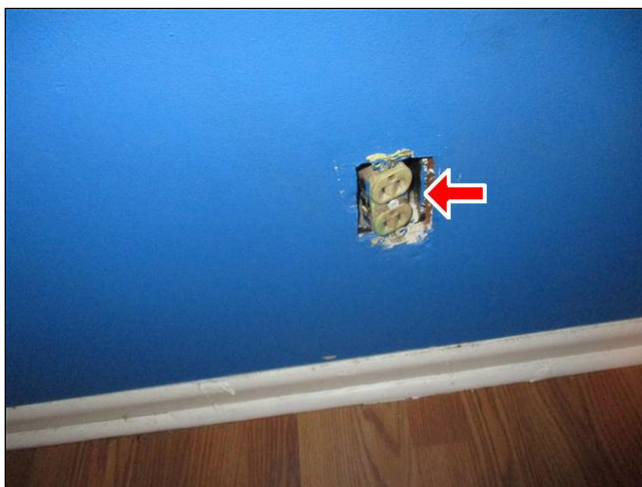
6.3 Item 4(Picture)

(3) It appeared that one receptacle was not secured well at the front corner bedroom. Repair or replace as needed.

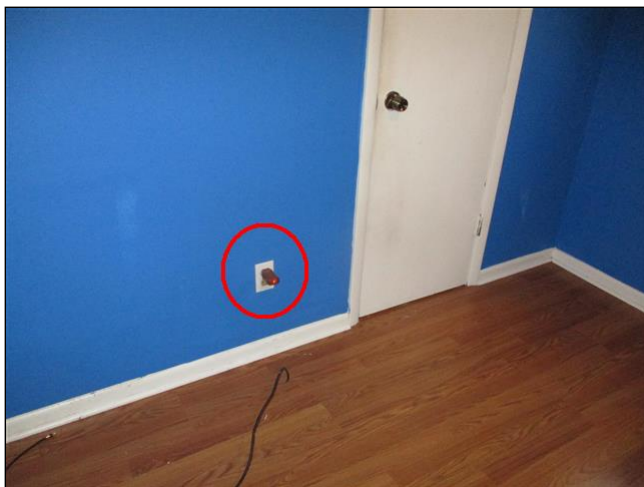
6.4 Item 1(Picture)

One receptacle showed open ground at the front corner bedroom. Repair as needed.

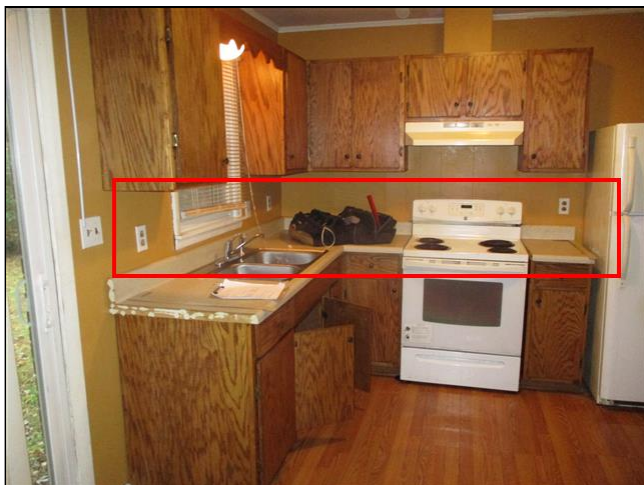
6.5 Item 1(Picture)

The receptacles appeared to have no GFCI protection at the laundry room, kitchen countertops and bathroom. We recommend that these receptacles have GFCI protection for safety enhancement. It is generally recommended that readily accessible receptacles within 6ft of wet areas have GFCI protection except for when dedicated non-GFCI protected circuits are needed. A GFCI outlet is an electrical outlet which is designed to protect people from deadly electric shock.

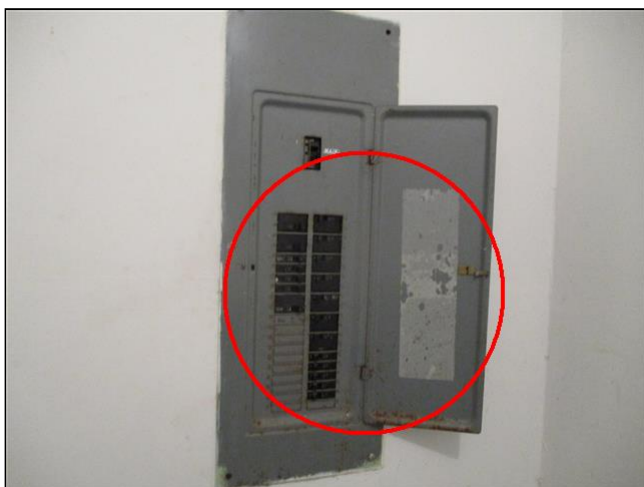
6.8 Item 1(Picture)

We recommend to label all circuit breakers.

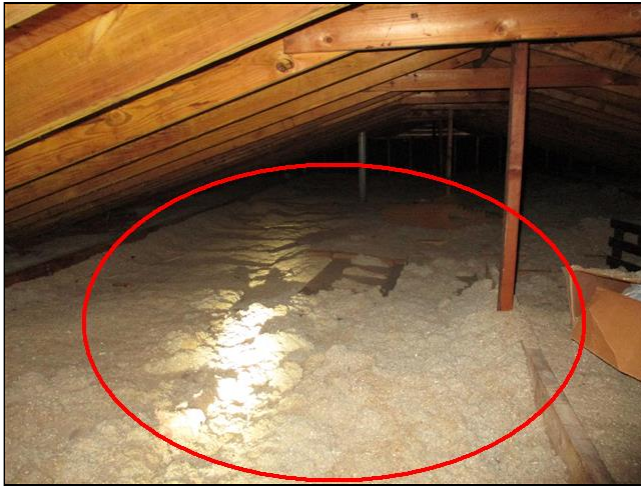
8.0 Item 1(Picture)

The insulation appeared to be low in most areas at the attic floor. We recommend that a qualified insulation contractor evaluate and add insulation as needed to help prevent energy loss.

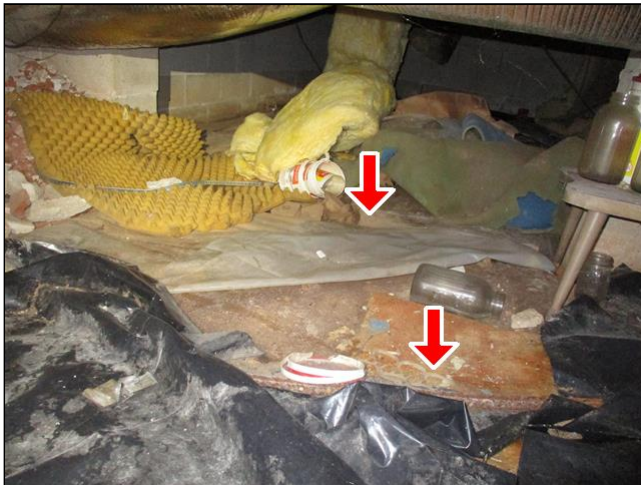
8.1 Item 1(Picture)

The plastic vapor retarder appeared to be missing in one area on the crawl space floor. The plastic vapor retarder resists diffusion of moisture from the dirt floor of the crawlspace. We recommend that all of the bare dirt floor be covered, we recommend to use 6mil or thicker black plastic, and we recommend that all seams overlap at least 6".
